July 13, 2021

**RE: NPDES Phase II Stormwater Assistance  
Pollution Prevention & Good Housekeeping for Municipal Operations  
Stormwater Treatment Structure Inspections**

## Town of Eastham, BMP-1, Structural Pretreatment BMP

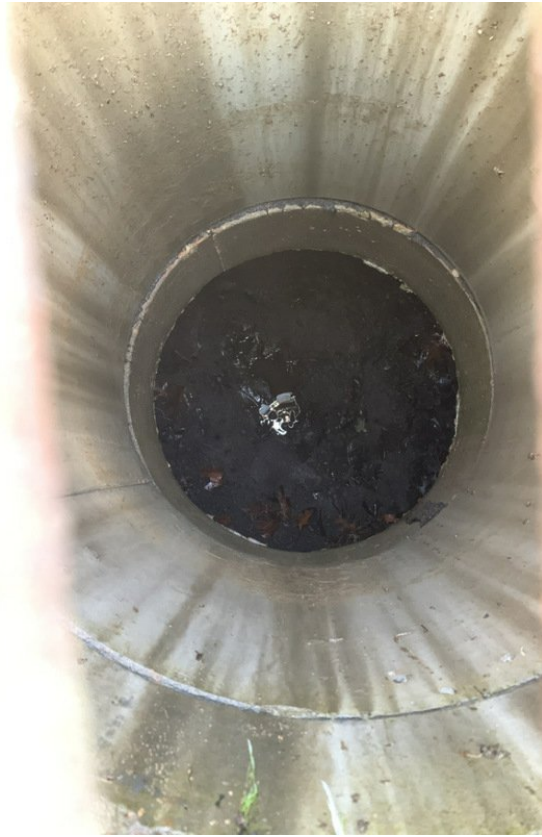
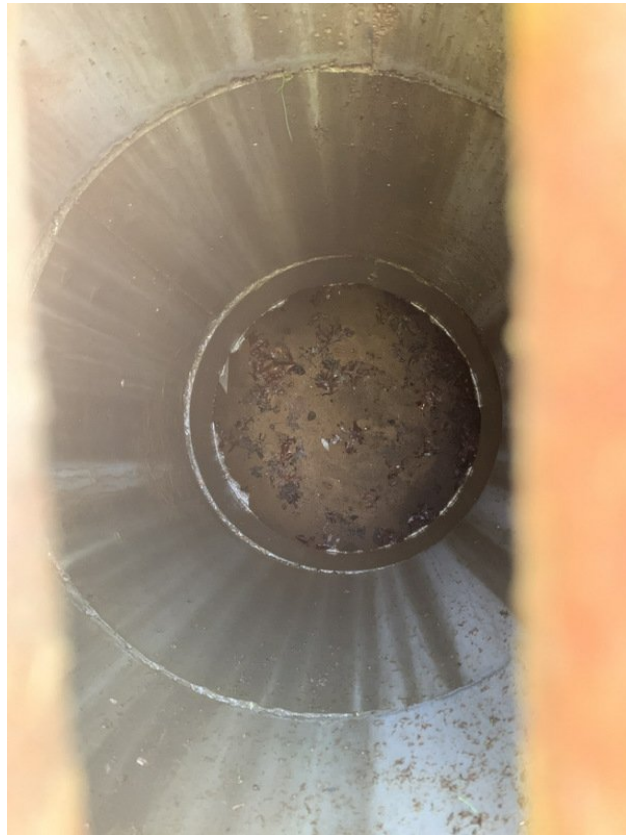
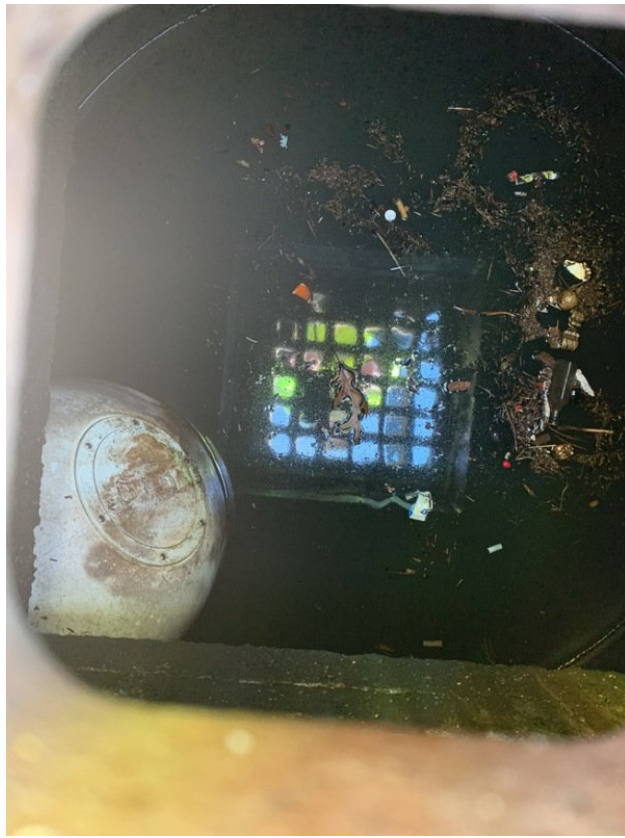
Is Status of BMP Satisfactory?	No
BMP Issue Location/Amount	Trash observed in basin structure.
Corrective Action Needed	Remove Trash/Debris

Is Status of BMP Satisfactory?	Yes
Notes	Continue with regular maintenance activity.
Inspection Summary	Continue to regularly clean catch basins and leaching pit to prevent excess sediment from flowing into the infiltration beds.

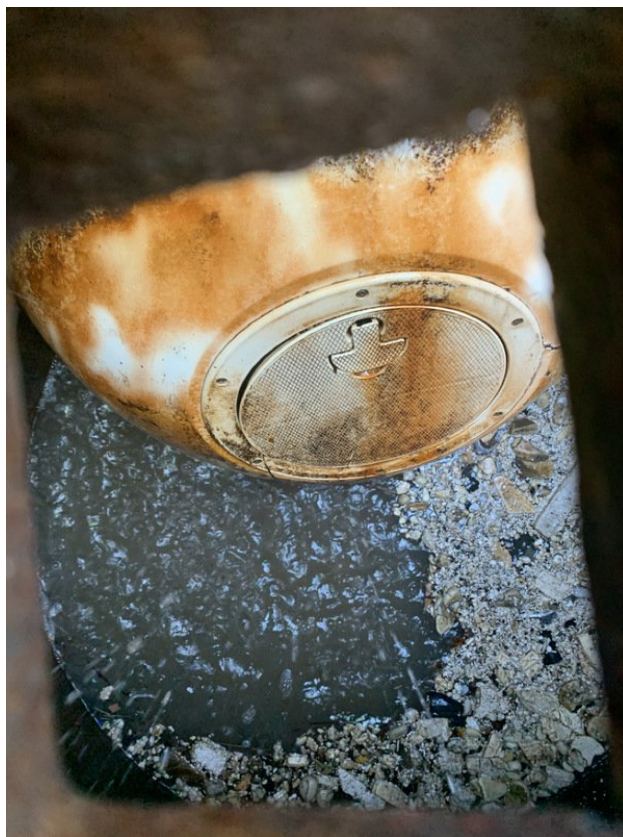
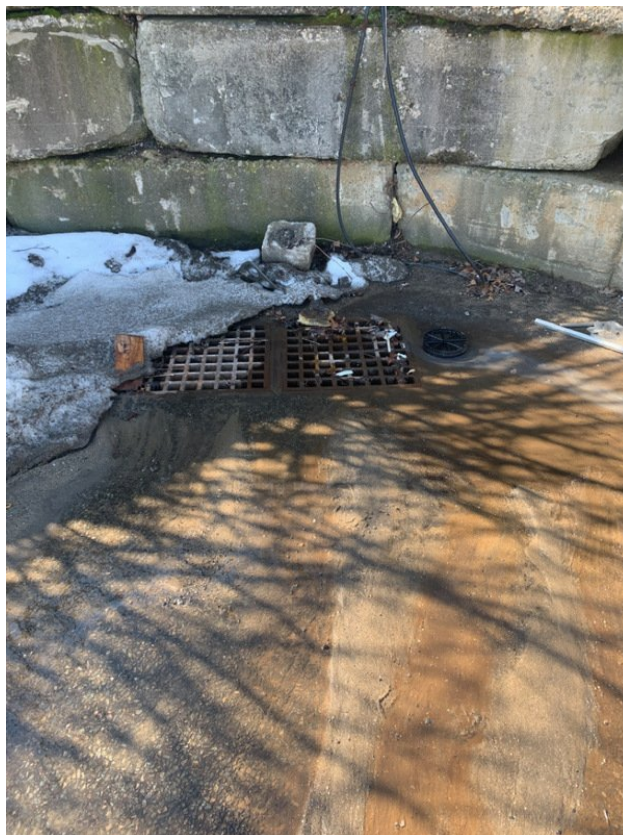
## Town of Eastham, BMP-2, Structural Pretreatment BMP

Inspection Summary	Catch basins appear to be functioning properly. Continue to keep the catch basin grates clear of garbage and remove sediment from the catch basin and manhole structures as needed.
--------------------	---

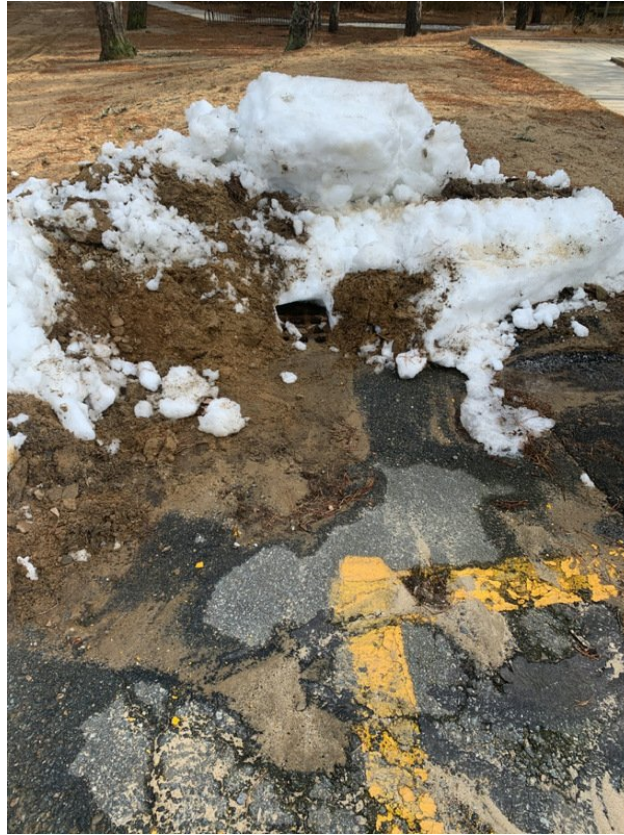
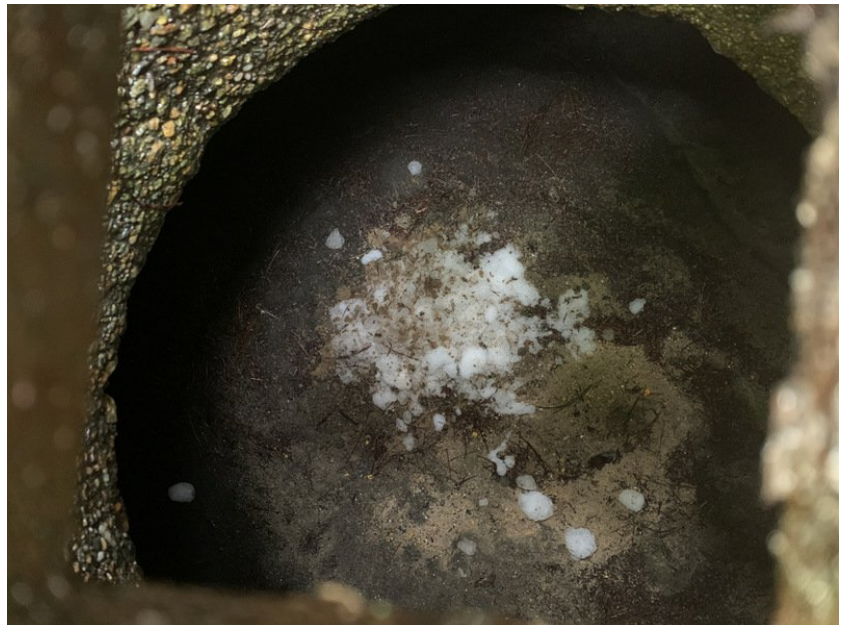
## Town of Eastham, BMP-3, Infiltration BMP

Is Status of BMP Satisfactory?	No
BMP Issue Location/Amount	Asphalt berm around CB is ineffective at keeping sand out
Corrective Action Needed	Build up berm to prevent sand erosion.

Is Status of BMP Satisfactory?	No
BMP Issue Location/Amount	Greater than 5' of sand in the catch basin.
Corrective Action Needed	Remove Sediment

Is Status of BMP Satisfactory?	Yes
Notes	Snow pile has kept some of the sand from entering the catch basin, but it could be filled up after melting and heavy rain.

This BMP requires regular inspection and cleaning as it is located next to a sandy beach. Consider redesigning the asphalt berm around the catch basin to prevent sand erosion.

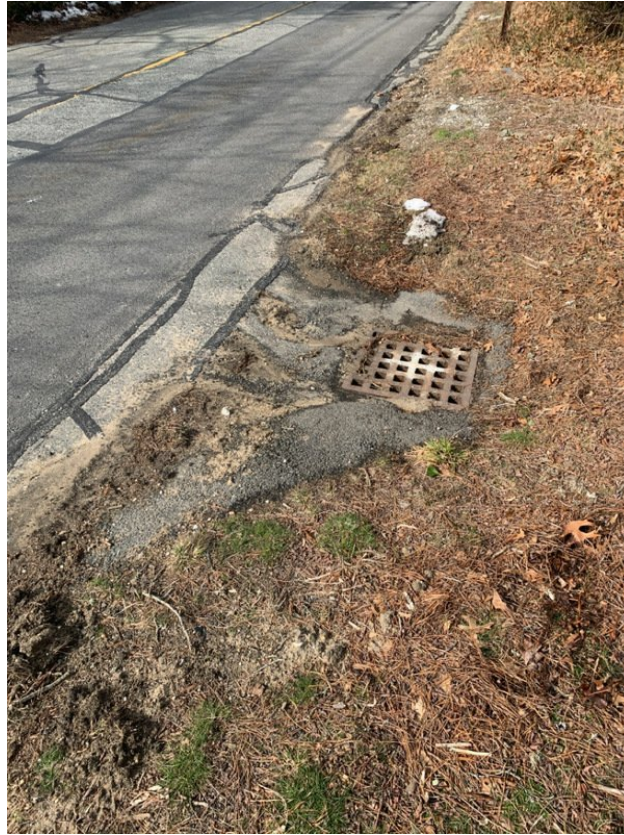
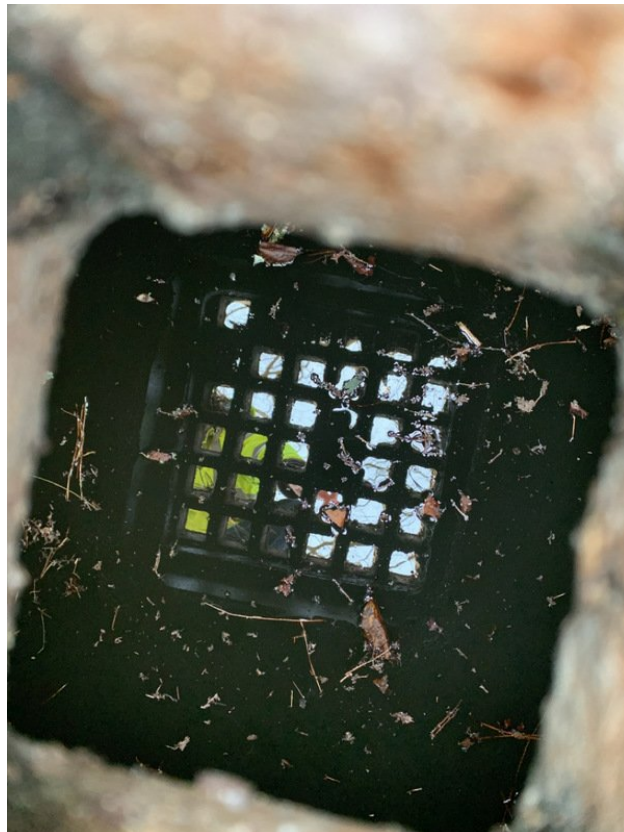
## Town of Eastham, BMP-4, Infiltration BMP

Is Status of BMP Satisfactory?	No
BMP Issue Location/Amount	CB grate clogged with sediment
Corrective Action Needed	Remove Sediment

Is Status of BMP Satisfactory?	No
BMP Issue Location/Amount	Crushed and clogged corrugated metal pipes in in North and South directions
Corrective Action Needed	Clean outlet and determine inlet/discharge location

Is Status of BMP Satisfactory?	No
BMP Issue Location/Amount	Very slow leaching rate, no standing water in BMP-5 across the street
Corrective Action Needed	Clean out and inspect

Is Status of BMP Satisfactory?	Yes
Notes	Standing water has lowered since 2019 inspection.

Crushed pipe should be cleaned out and inspected to determine connectivity. Presence of standing water in the structure indicates that water is leaching out at a slow rate. Catch basin should be cleaned out to determine the cause of water retention.

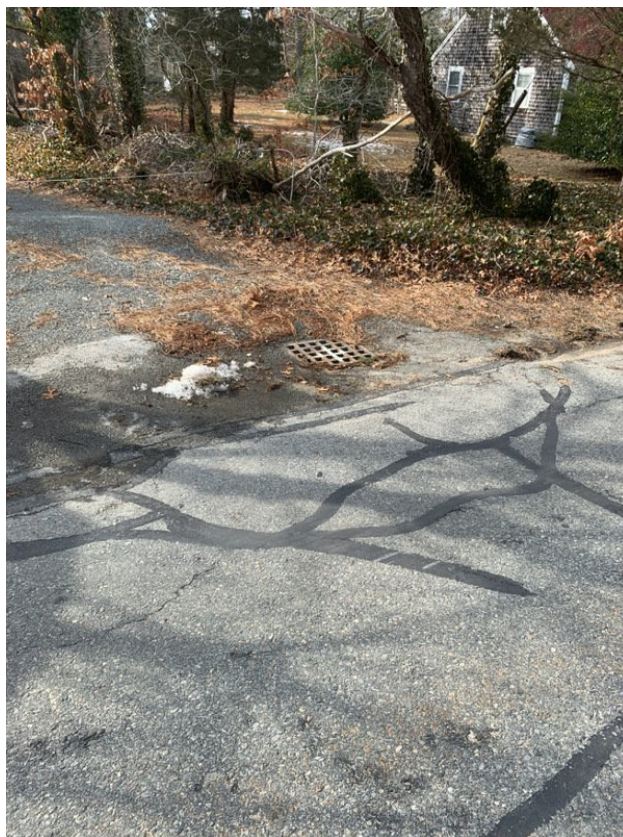
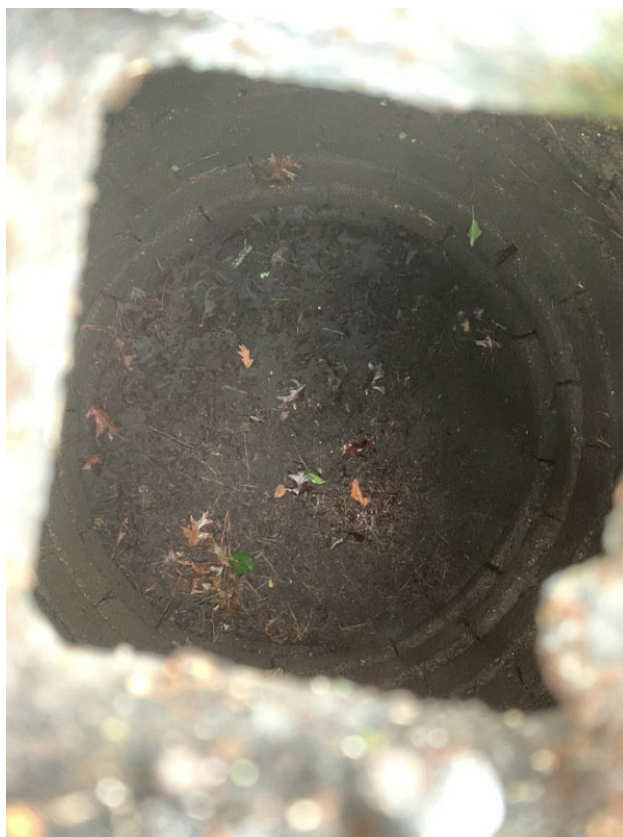
## Town of Eastham, BMP-5, Infiltration BMP

Is Status of BMP Satisfactory?	No
BMP Issue Location/Amount	Leaves, pine needles and debris in basin
Corrective Action Needed	Remove Sediment

Is Status of BMP Satisfactory?	No
BMP Issue Location/Amount	Crushed corrugated metal pipe running south from/to this catch basin
Corrective Action Needed	Clean outlet and determine inlet/discharge location

Is Status of BMP Satisfactory?	Yes
Notes	Barrel block structure seemingly leaches water.
Inspection Summary	Crushed pipe should be cleaned out and inspected to determine connectivity. Sediment and leaves need to be cleaned out. Absence of standing water in the structure indicates that water is leaching out.

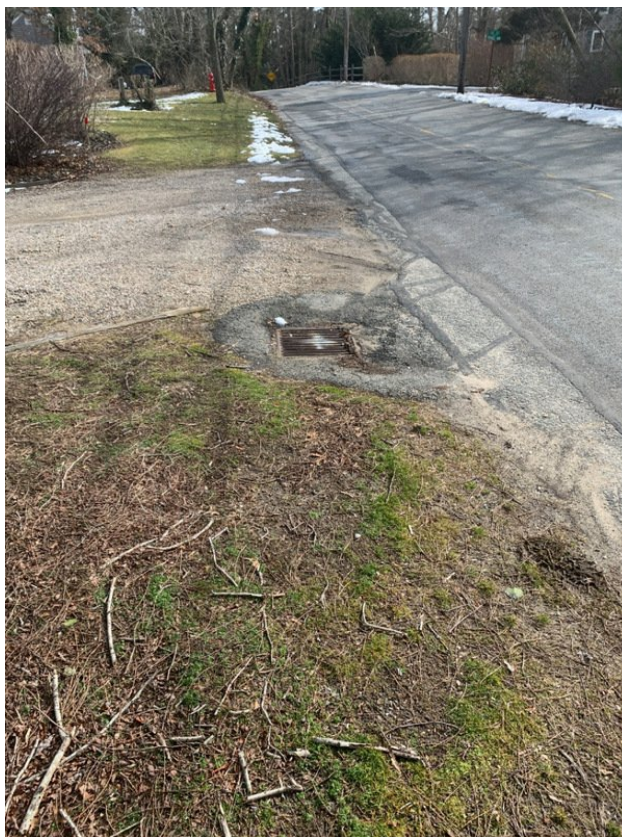
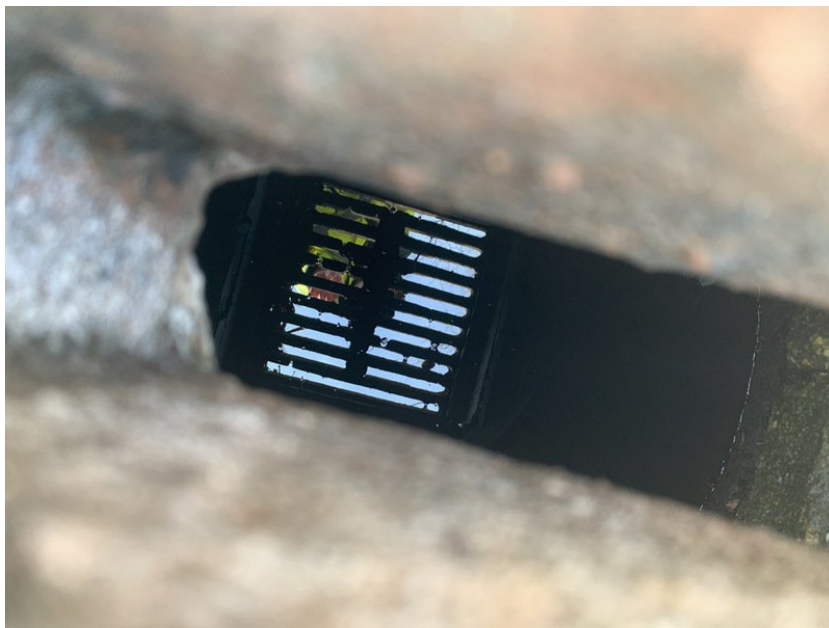
## Town of Eastham, BMP-6, Infiltration BMP

Is Status of BMP Satisfactory?	Yes
Notes	Barrel Block structure with Corrugated Metal outlet towards SSE direction
Inspection Summary	Catch basin appears to connect to a buried leaching facility in the driveway to the South East.

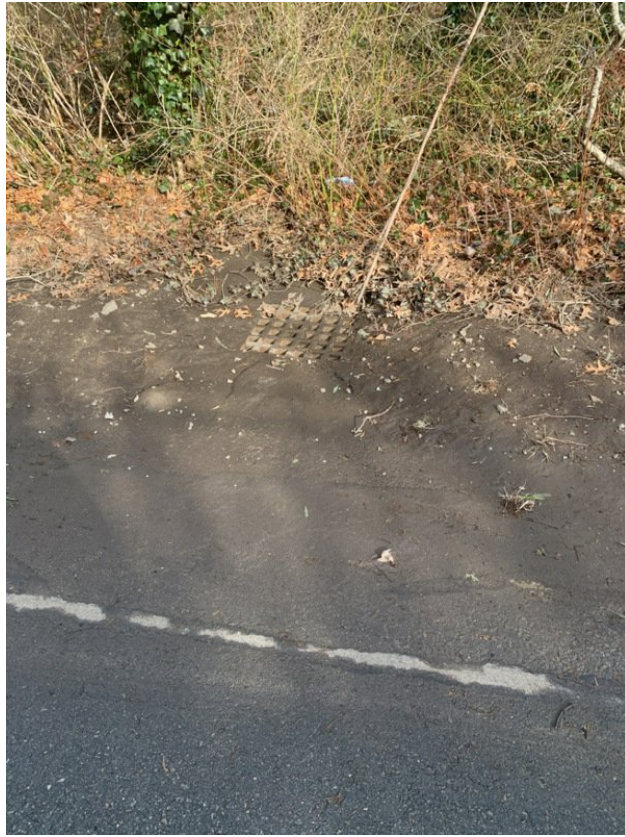
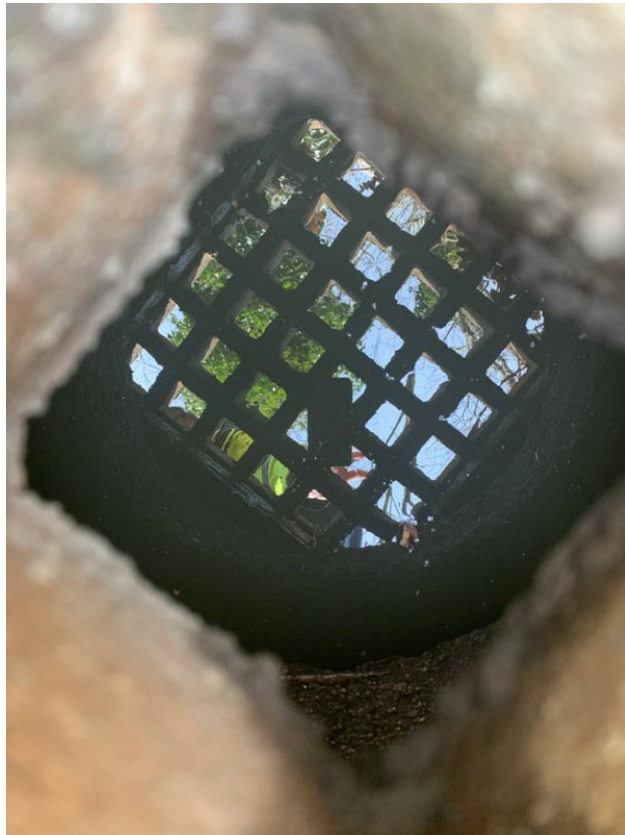
## Town of Eastham, BMP-7, Infiltration BMP

Is Status of BMP Satisfactory?	Yes
Inspection Summary	Standing water in the structure indicates the structure is clogged and water is leaching out at a slow rate. Catch basin should be cleaned out to determine the cause of water retention.

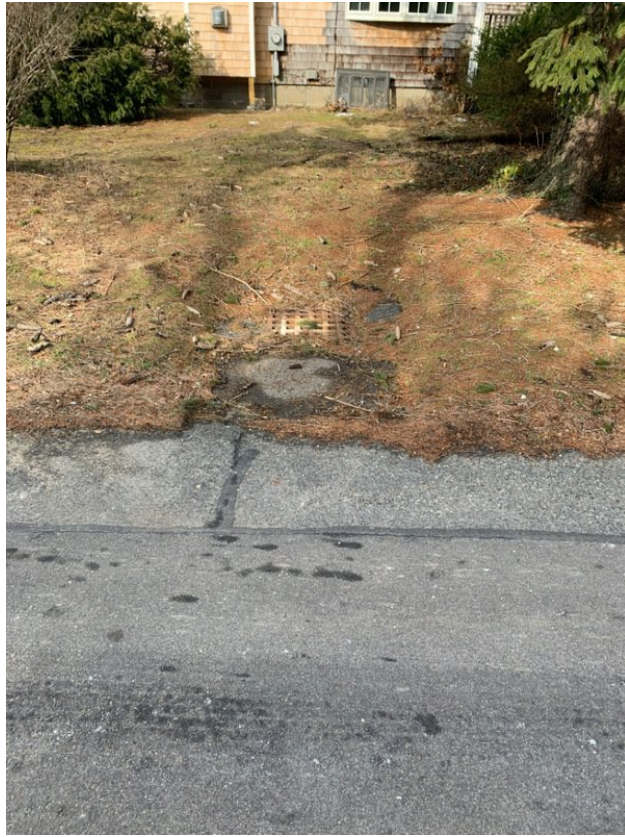
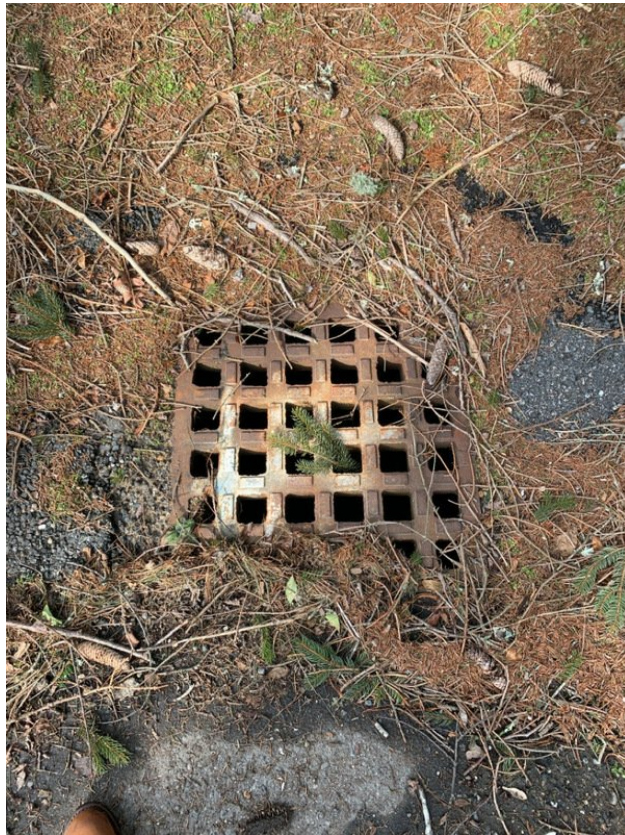
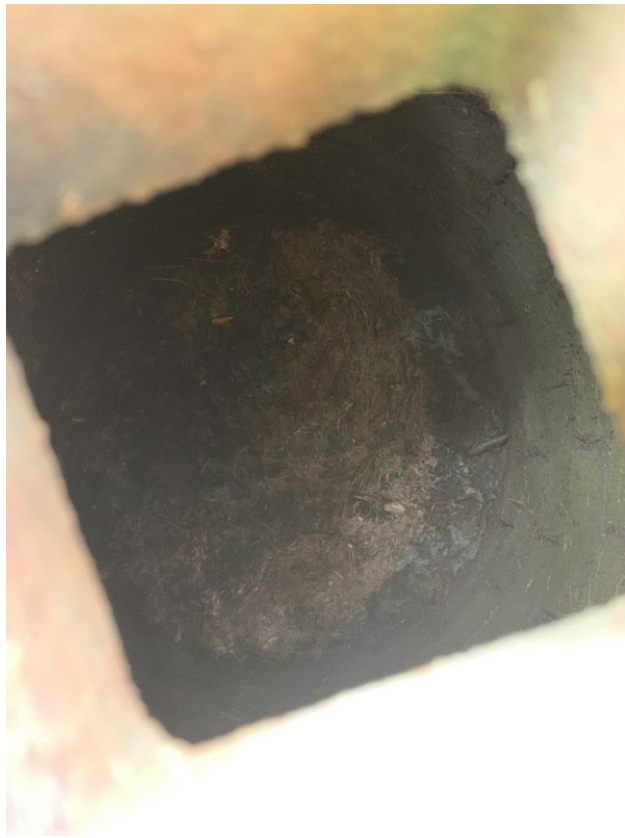
## Town of Eastham, BMP-8, Infiltration BMP

Is Status of BMP Satisfactory?	Yes
Notes	Overflow pipe to BMP-9 across the street appears to have been crushed.
Inspection Summary	Sediment needs to be removed on a regular basis. No standing water indicates that the leaching CB is functioning.

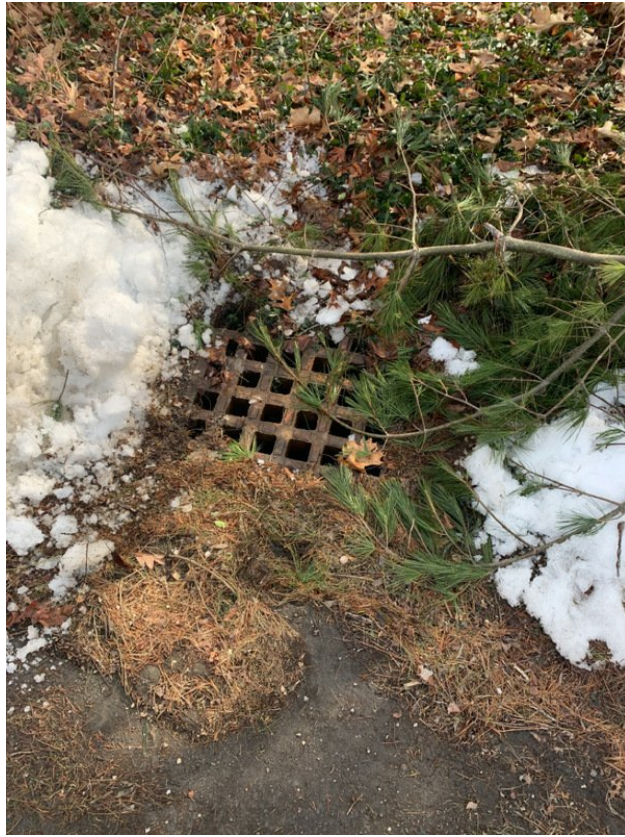
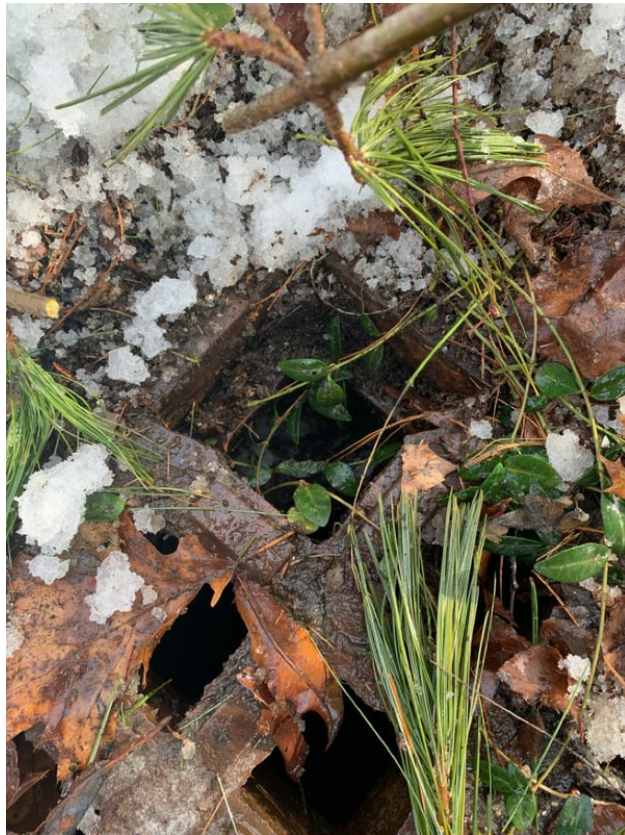
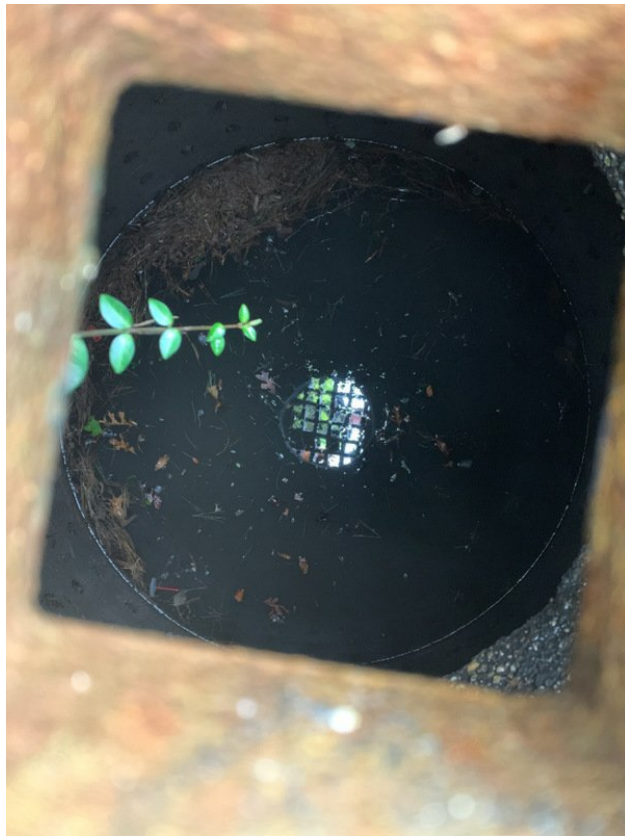
## Town of Eastham, BMP-9, Infiltration BMP

Is Status of BMP Satisfactory?	No
BMP Issue Location/Amount	Corners of CB grate are broken
Corrective Action Needed	consider replacement grate
Notes	Presence of standing water indicates that the leaching CB is functioning properly.
Inspection Summary	Sediment needs to be removed on a regular basis. Consider replacing broken grate.
Photos

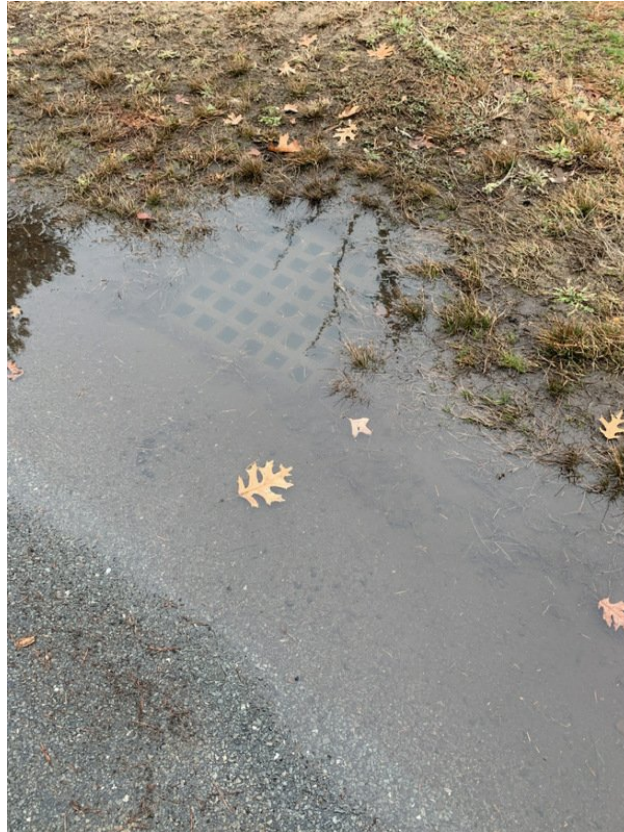
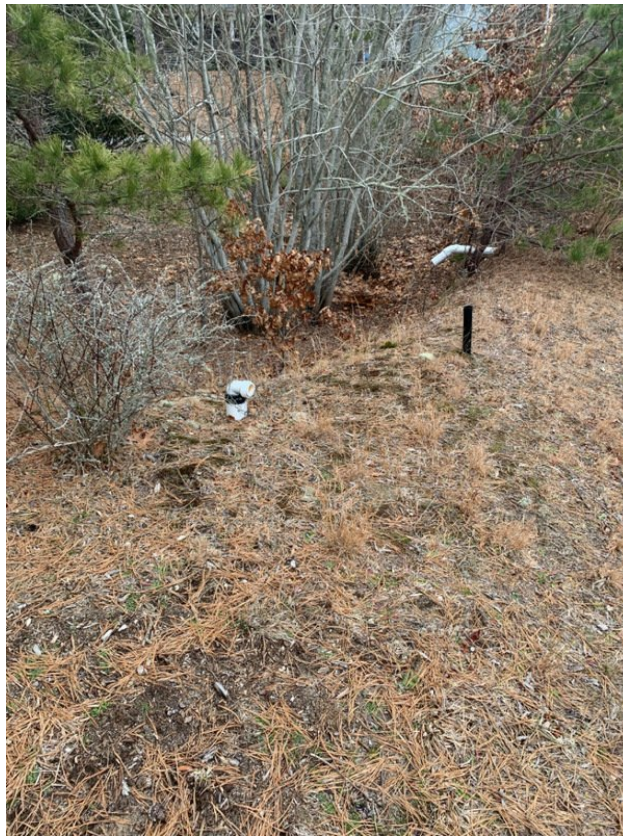
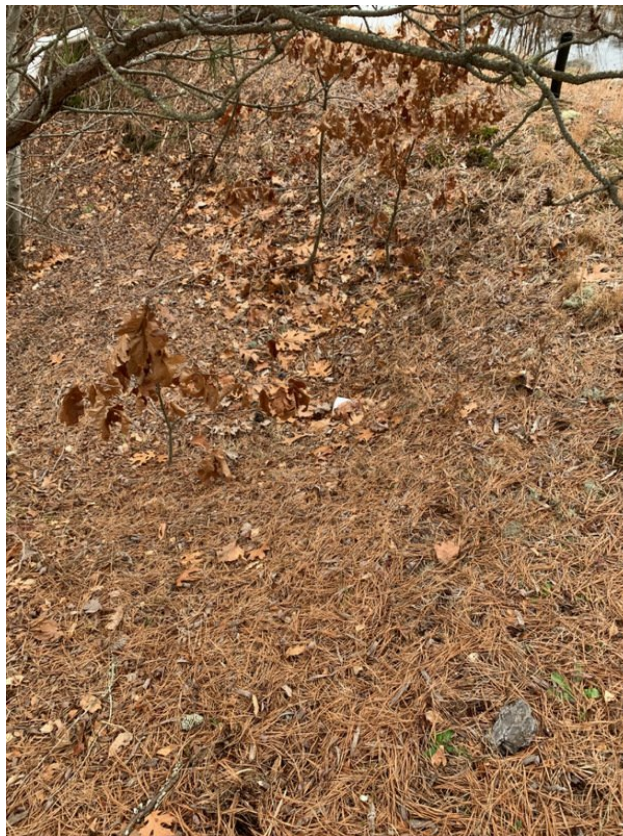
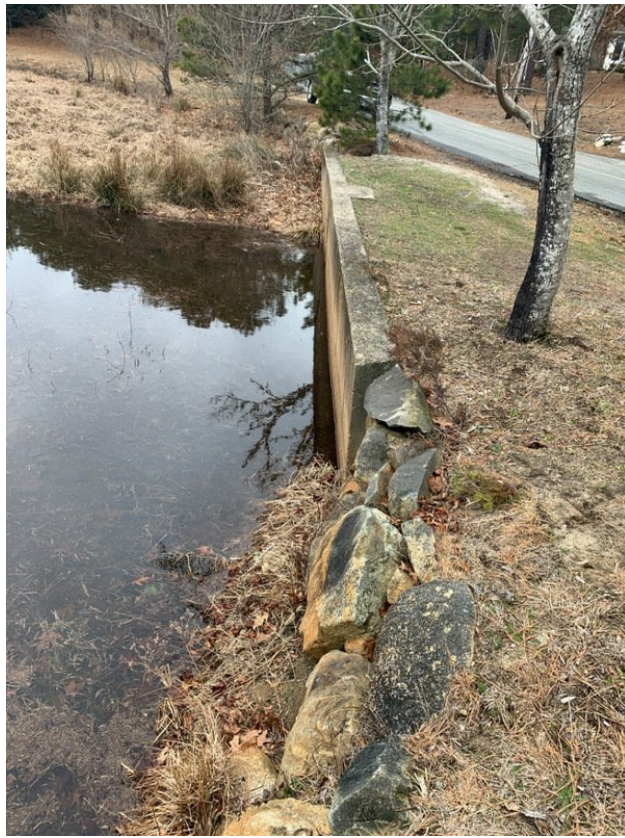
## Town of Eastham, BMP-10, Unknown

Inspection Summary  
 The designed intent of this BMP needs to be identified by town personnel or design drawings.

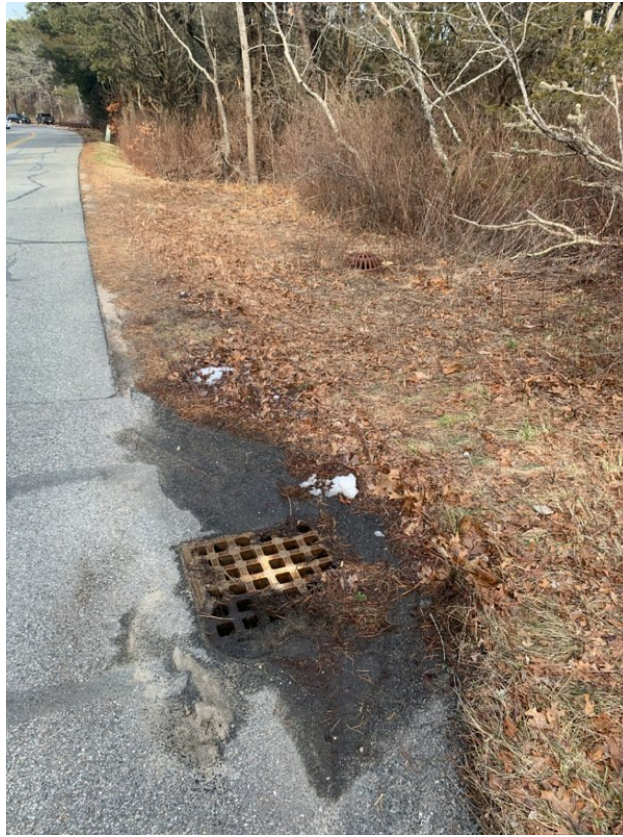
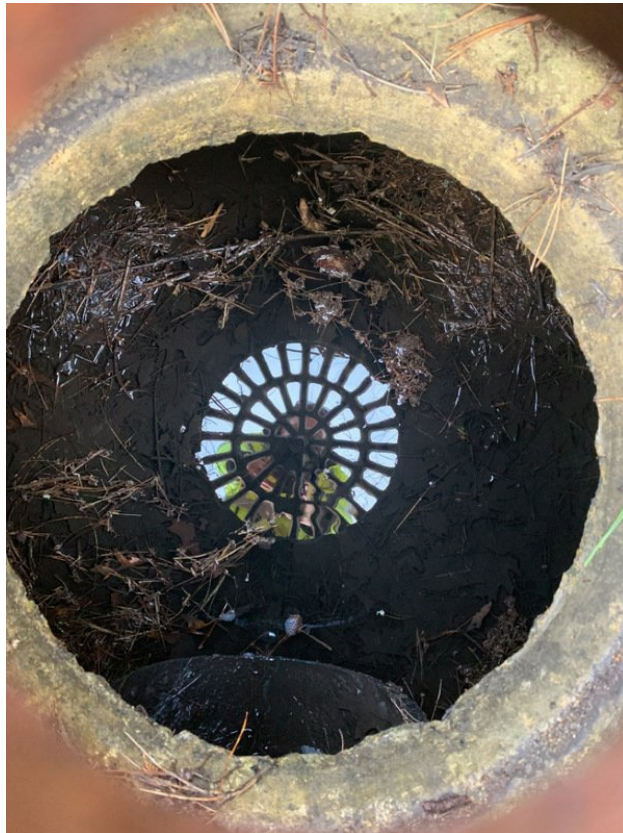
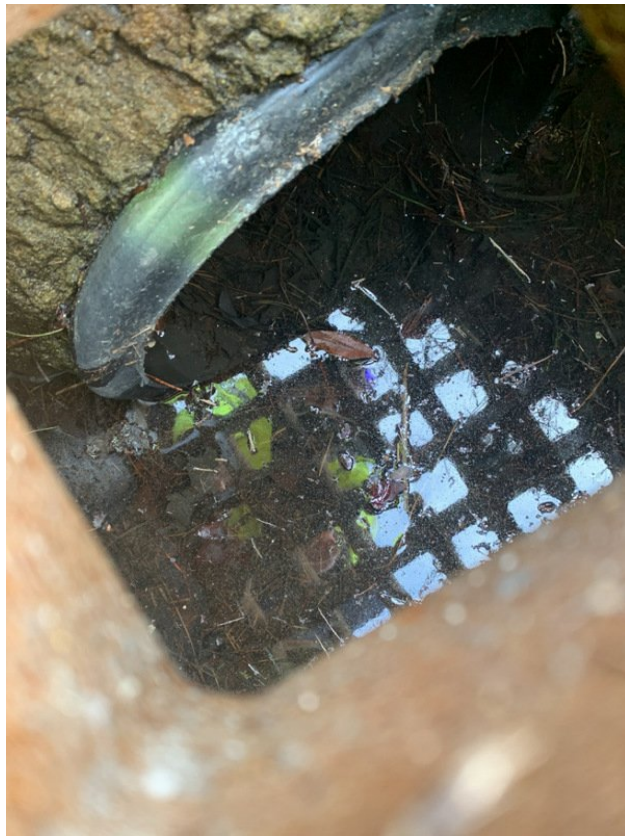
## Town of Eastham, BMP-11, Infiltration BMP

Is Status of BMP Satisfactory?	Yes
Notes	12" HDPE pipe has bend approximately 3' out of gutter inlet.
Inspection Summary	Brush should be maintained to allow access to the leaching basin. Sediment in the leaching catch basin and the leaching pit needs to be removed. This BMP should be inspected on a regular basis and cleaned out as needed.

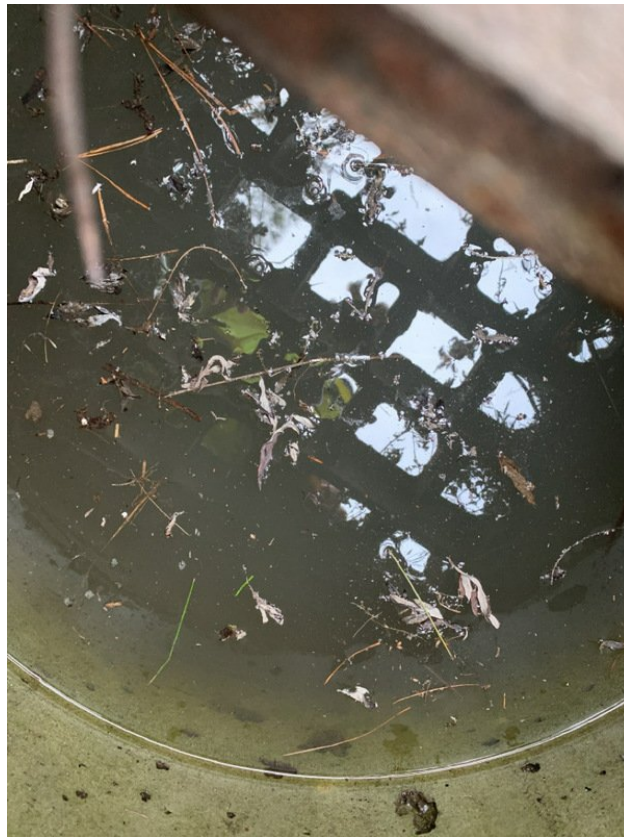
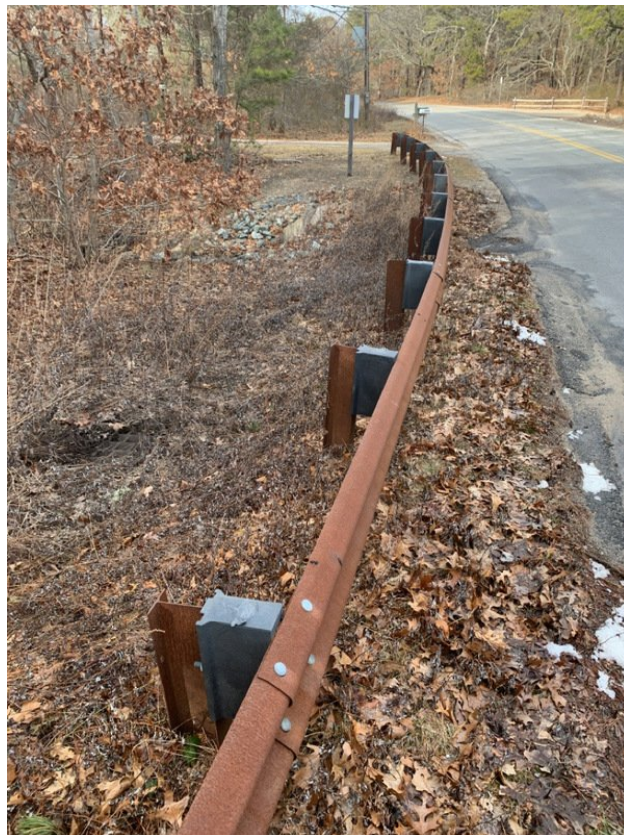
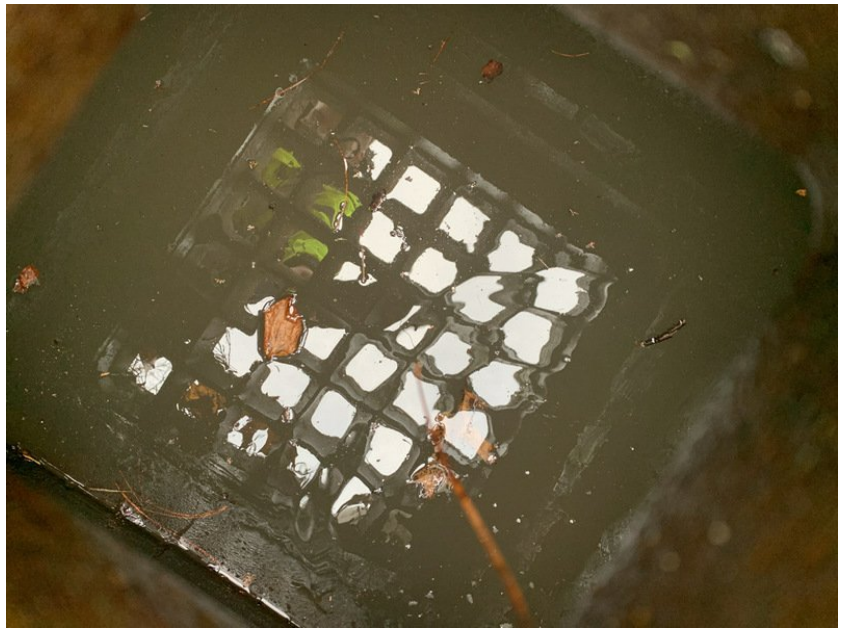
## Town of Eastham, BMP-12, Infiltration BMP

Is Status of BMP Satisfactory?	No
BMP Issue Location/Amount	Standing water in leaching basin.
Corrective Action Needed	Remove sediment in leaching basin to improve infiltration rates.

Is Status of BMP Satisfactory?	Yes
Notes	Deep sump catch basin with hood runs to structure with cascading frame & grate, approximately 20' to the southwest.
Inspection Summary	Brush should be maintained to allow access to the leaching basin. Design plans should be reviewed to determine if standing water is groundwater.

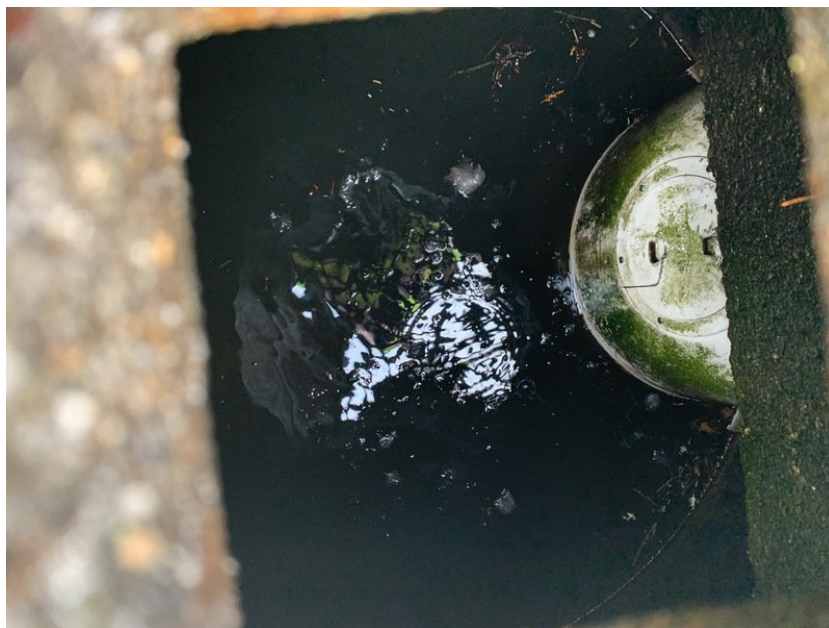
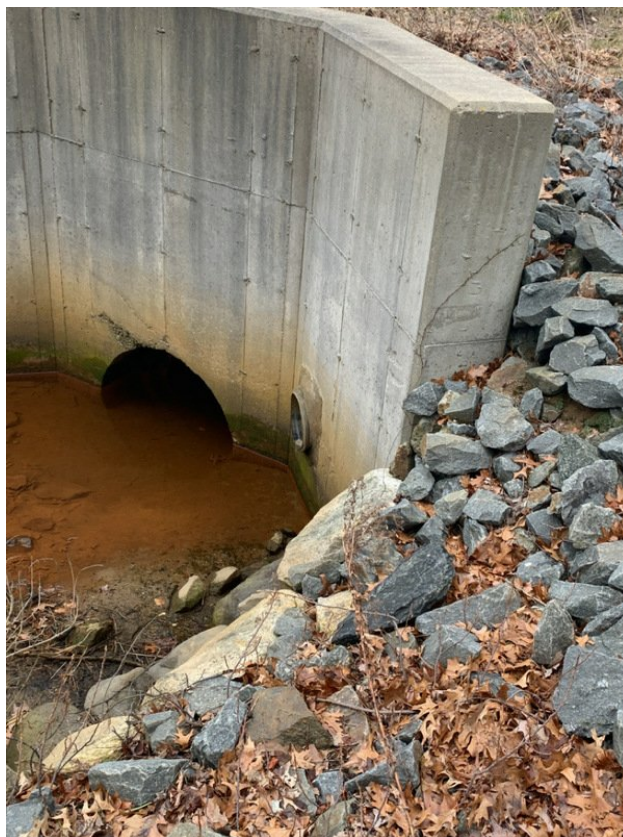
## Town of Eastham, BMP-13, Infiltration BMP

Is Status of BMP Satisfactory?	Yes
Notes	Deep sump catch basin flows into a leaching basin. The leaching basin has an overflow that discharges at a nearby culvert headwall.
Inspection Summary	Leaching basin should be inspected regularly and cleaned out as necessary.

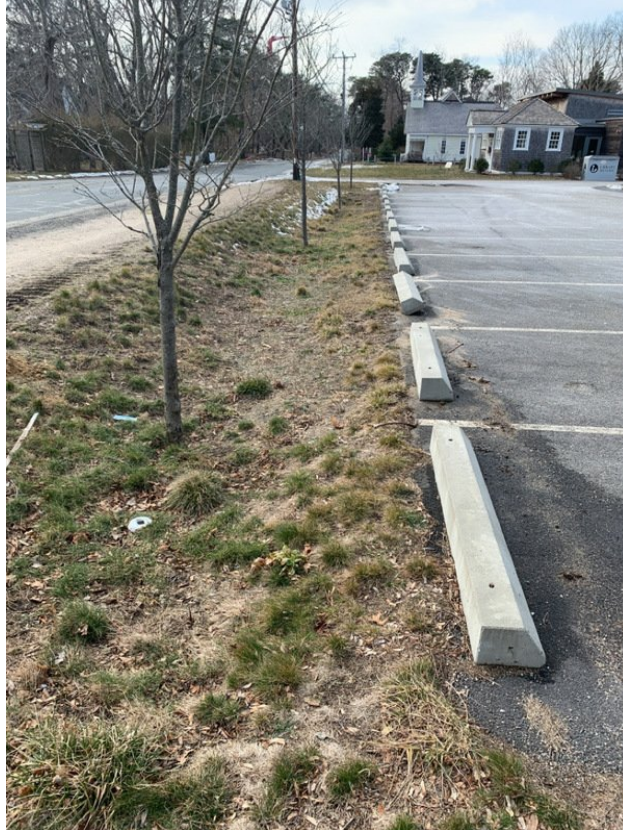
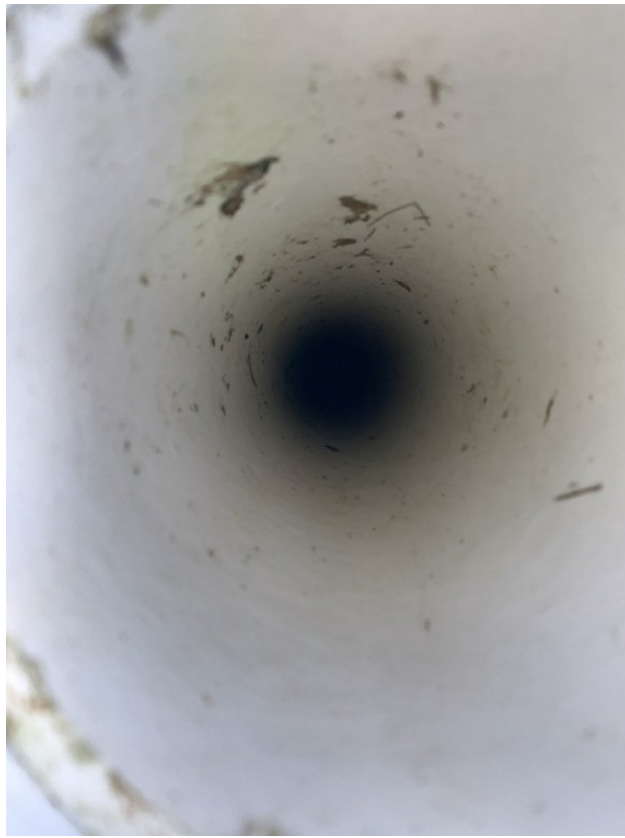
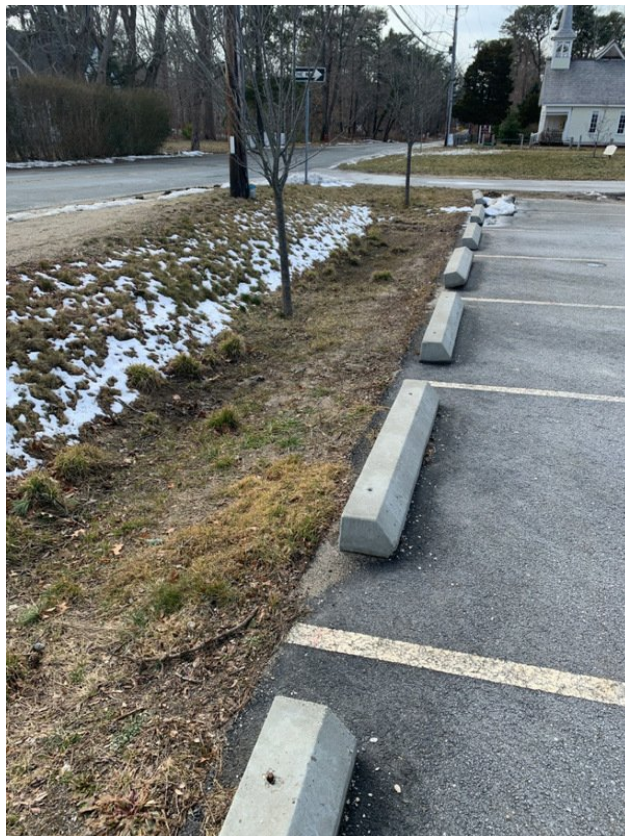
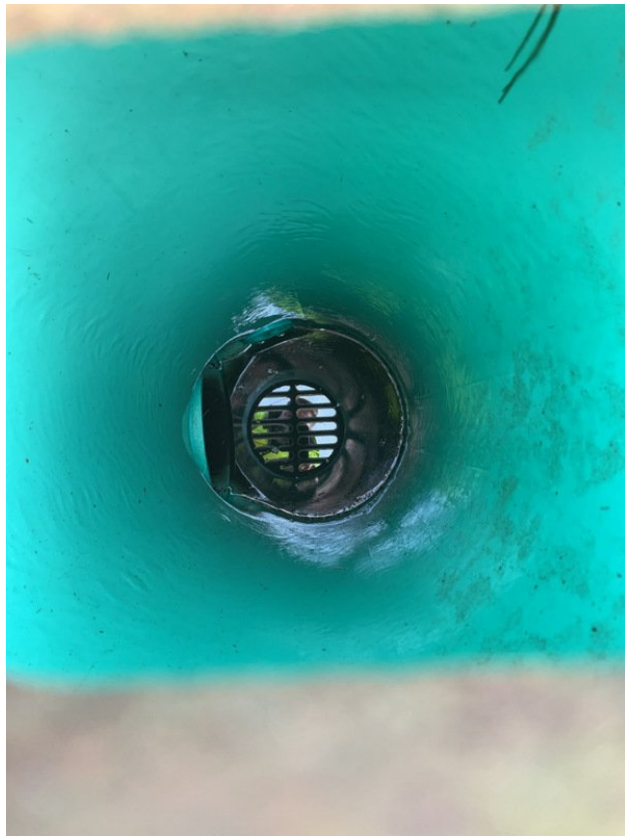
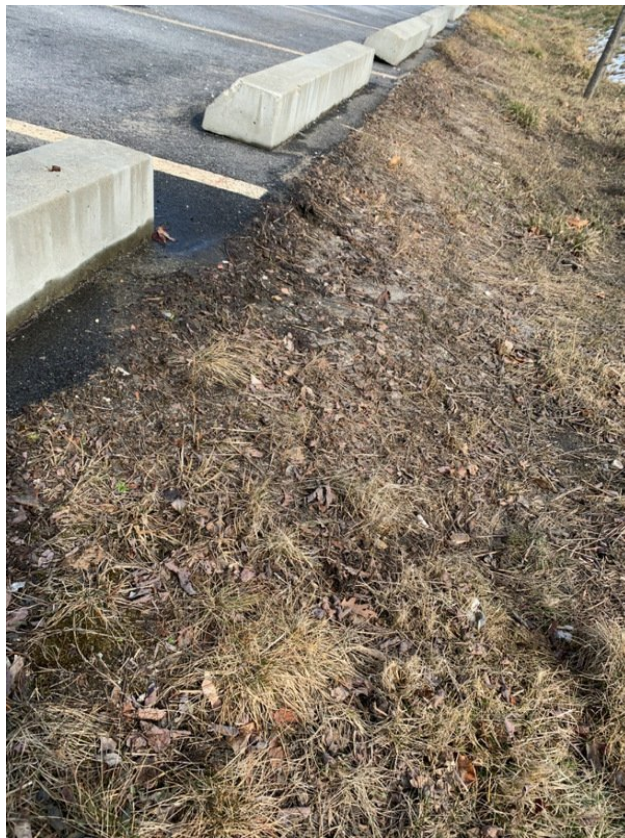
## Town of Eastham, BMP-14, Treatment BMP

Inspection Summary Weeds need to be removed from the BMP. Increase vegetation on bare slide slopes.
