Bridge Pond, Eastham MA

Bridge Pond Water Quality Summary

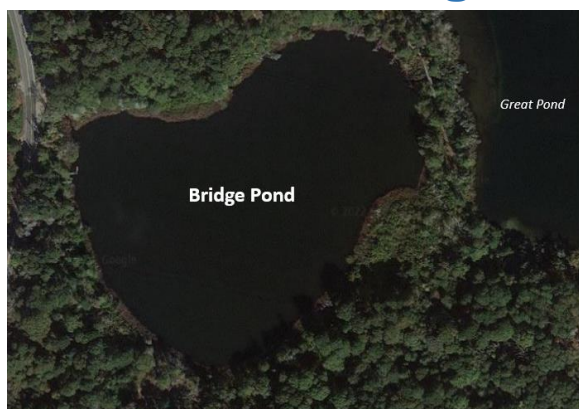
- Stable water quality conditions, 2009-2021
- Hydrologically connected to Great Pond (inflow) and Herring Brook (outflow)

- Pond bordered by park/conservation lands, Herring Brook Road only development. No residences within 100 m of pond
- Increasing trend in dissolved oxygen
- Possible sediment release of phosphorus
- Potential external phosphorus sources: birds, precipitation, roads, Great Pond

- Manage Great Pond phosphorus concentrations
- Maintain vegetated shoreline
- Discourage large flocks of birds
- Control road runoff

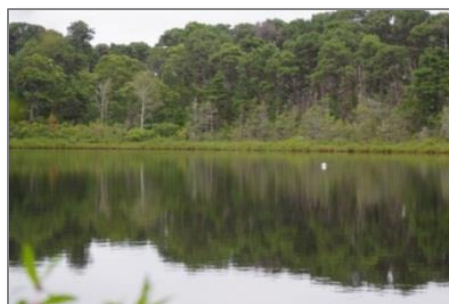
Water Column	Parameter	Result ¹	“Healthy” Ponds Thresholds ²
Upper Waters	Total Phosphorus	21.6 µg/L	≤10 µg/L
	Chlorophyll-a	15.1 µg/L	≤1.7 µg/L
	Secchi Disk Transparency	2.73 m	Not calculated
Lower Waters	Total Phosphorus	42 µg/L	--
	Dissolved Oxygen	4 mg/L	--

¹Annual average results (PALS) - total phosphorus, chlorophyll-a, Secchi disk transparency, and dissolved oxygen, 2012-2021.

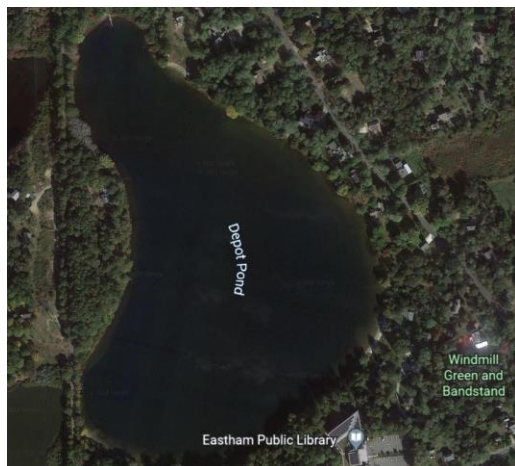
Depot Pond, Eastham MA

- Seasonal oxygen depletion in deep waters
- Emerging trends: Increasing chlorophyll-a, decreasing total phosphorus

- Major phosphorus sources: Septic (0-44%), birds (31-38%), roads (7-25%), roofs (7-25%)
- 6 residences within 300 ft. upgradient

- Alum treatment program
- Aeration

- Septic system maintenance

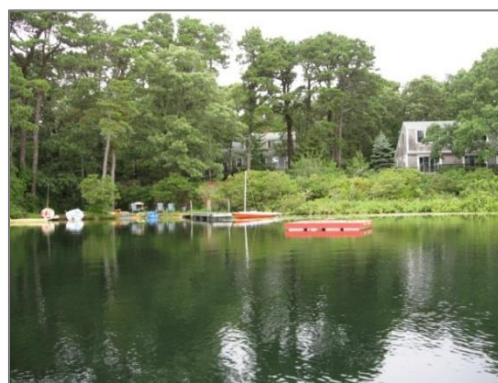
Depot Pond Water Quality Summary

Water Column	Parameter	Result ¹	"Healthy" Ponds Thresholds ²
Upper Waters	Total Phosphorus	18 µg/L	≤10 µg/L
	Chlorophyll-a	13 µg/L	≤1.7 µg/L
	Secchi Disk Transparency	3.1 m	Not calculated
Lower Waters	Total Phosphorus	28 µg/L	--
	Dissolved Oxygen	3 mg/L	--

¹Annual average results (PALS) - total phosphorus, chlorophyll-a, Secchi disk transparency, and dissolved oxygen, 2012-2021.

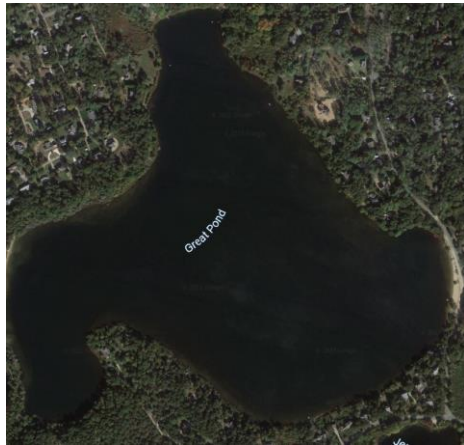
Great Pond, Eastham MA

- 22 properties within 300 ft. upgradient
- Discharges to Bridge Pond; herring run from Herring Brook through Bridge Pond.

- Positive response to 2013 alum treatment program
- Slight increasing trend in phosphorus concentrations

- Continue to monitor effectiveness of 2013 alum treatment program, evaluate future treatment

- Septic system maintenance/upgrades
- Replace septic systems with sewers
- Maintain shoreline vegetative buffers

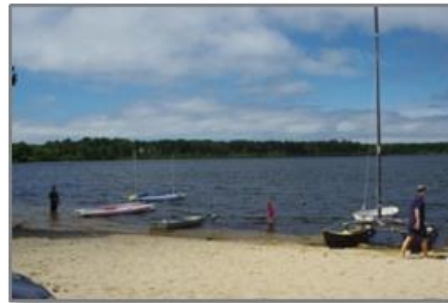
Great Pond Water Quality Summary

Water Column	Parameter	Result ¹	"Healthy" Ponds Thresholds ²
Upper Waters	Total Phosphorus	19.7 µg/L	≤10 µg/L
	Chlorophyll-a	9.3 µg/L	≤1.7 µg/L
	Secchi Disk Transparency	2.8 m	Not calculated
Lower Waters	Total Phosphorus	27.4 µg/L	--
	Dissolved Oxygen	2.1 mg/L	--

¹Annual average results (PALS) - total phosphorus, chlorophyll-a, Secchi disk transparency and dissolved oxygen, 2014-2021 (post alum treatment)

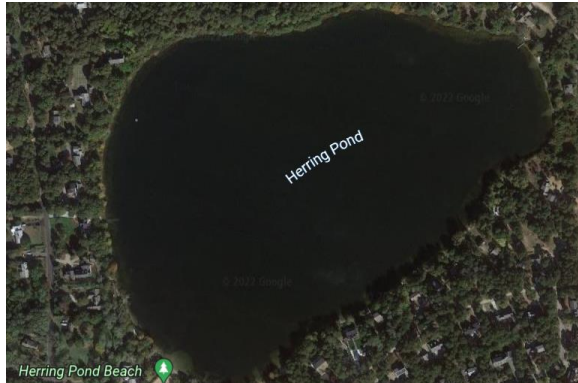
Herring Pond, Eastham MA

- Positive response to 2012 alum treatment, large increase in Secchi disk transparency readings
- Dissolved oxygen concentrations increasing in deep waters

- 20 leach fields within 300 ft. (upgradient)

- Continue to track effectiveness of 2012 alum treatment program, consider repeating treatment

- Septic system maintenance
- Residential and lawn practices

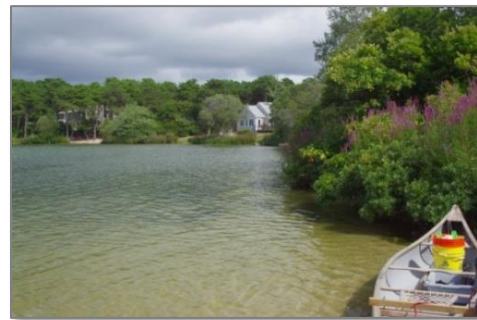
Herring Pond Water Quality Summary

Water Column	Parameter	Result ¹	"Healthy" Ponds Thresholds ²
Upper Waters	Total Phosphorus	16.8 µg/L	≤10 µg/L
	Chlorophyll-a	9.6 µg/L	≤1.7 µg/L
	Secchi Disk Transparency	4.2 m	Not calculated
Lower Waters	Total Phosphorus	28.6 µg/L	--
	Dissolved Oxygen	6.7 mg/L	--

¹Annual average results (PALS) - total phosphorus, chlorophyll-a, Secchi disk transparency, and dissolved oxygen, 2013-2021 (post alum treatment)

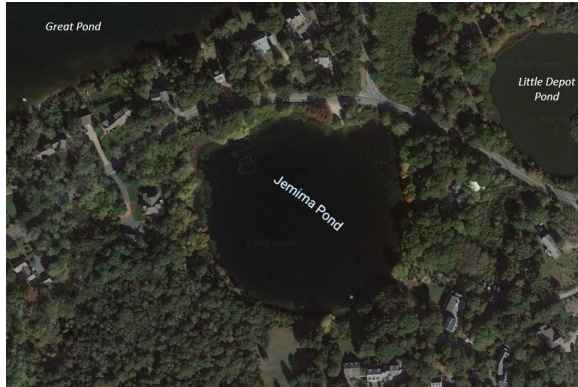
Jemima Pond, Eastham MA

- Stable water quality conditions, 2003-2021
- Well-mixed water column, no evidence of dissolved oxygen depletion
- Six residences within 300 ft. upgradient
- Possible phosphorus sources: birds, septic, precipitation, road runoff

- Maintain or upgrade septic systems
- Maintain vegetated shoreline
- Discourage large flocks of birds
- Control road runoff

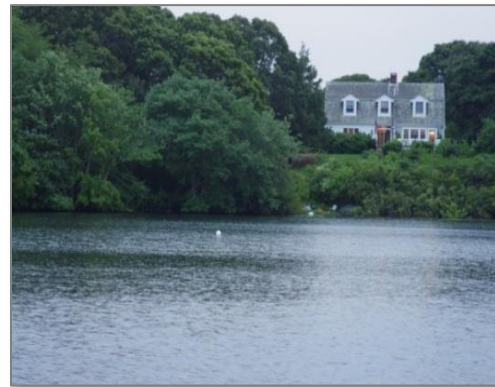
Jemima Pond Water Quality Summary

Water Column	Parameter	Result ¹	"Healthy" Ponds Thresholds ²
Upper Waters	Total Phosphorus	23.7 µg/L	≤10 µg/L
	Chlorophyll-a	10.6 µg/L	≤1.7 µg/L
	Secchi Disk Transparency	2.7 m	Not calculated

¹Annual average results (PALS) - total phosphorus, chlorophyll-a, and Secchi disk transparency, 2012-2021.

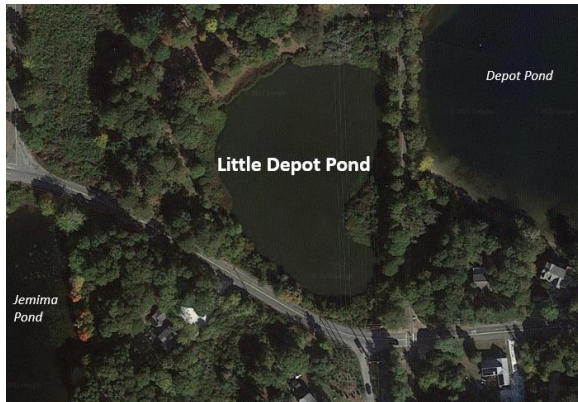
Little Depot Pond, Eastham MA

- Impacted by human activities
- Water column well-mixed
- Possible phosphorus sources: birds, septic, precipitation, road runoff (Samoset)

- Maintain/upgrade septic systems
- Retain vegetated shoreline
- Discourage large flocks of birds
- Reduce road runoff

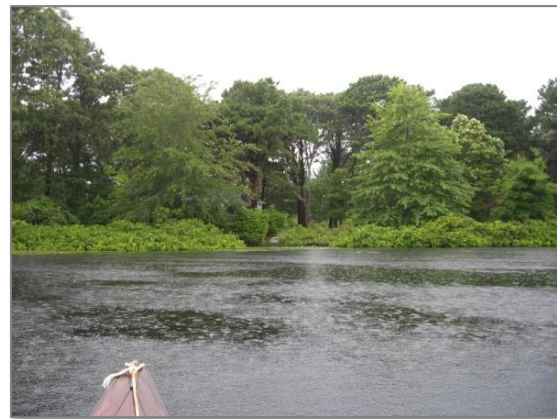
Little Depot Pond Water Quality Summary

Water Column	Parameter	Result ¹	"Healthy" Ponds Thresholds ²
Upper Waters	Total Phosphorus	50 µg/L	≤10 µg/L
	Chlorophyll-a	28.6 µg/L	≤1.7 µg/L
	Secchi Disk Transparency	1.3 m	Not calculated
Lower Waters	Total Phosphorus	92 µg/L	--
	Dissolved Oxygen	1.7 mg/L	--

¹Annual average results (PALS) - total phosphorus, Secchi disk transparency, dissolved oxygen, and chlorophyll-a, 2012-2021.

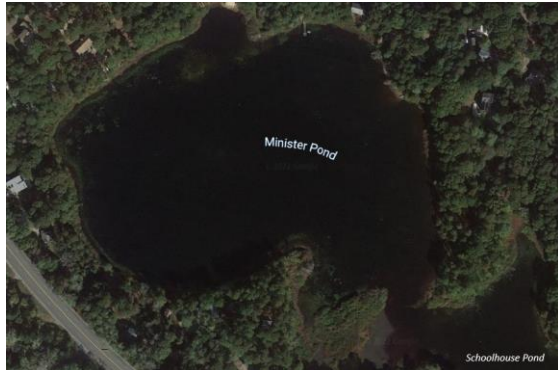
Minister Pond, Eastham MA

- Town implementing in-lake remedial measures (aeration, hydroraking) and watershed protective measures (green infrastructure) with SOLitude and Horsley-Whitten group.
- Dissolved oxygen increased in lower waters

- Major phosphorus sources: Roads (29-60%), septic (0-45%); sediment not quantified
- Hydrologically connected to Schoolhouse (pictured to the left)

- Aeration or alum treatment

- Septic system maintenance
- Maintain vegetated shoreline
- Mitigate roadway runoff

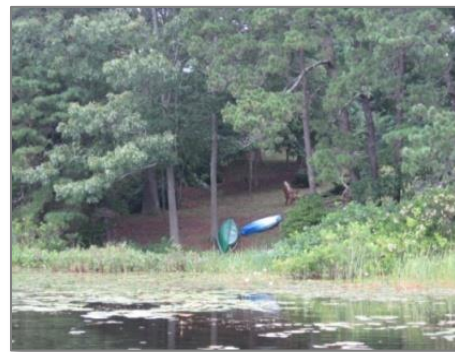
Minister Pond Water Quality Summary

Water Column	Parameter	Result ¹	“Healthy” Ponds Thresholds ²
Upper Waters	Total Phosphorus	30.2 µg/L	≤10 µg/L
	Chlorophyll-a	17.4 µg/L	≤1.7 µg/L
	Secchi Disk Transparency	1.76 m	Not calculated
Lower Waters	Total Phosphorus	51.4 µg/L	--
	Dissolved Oxygen	3.13 mg/L	--

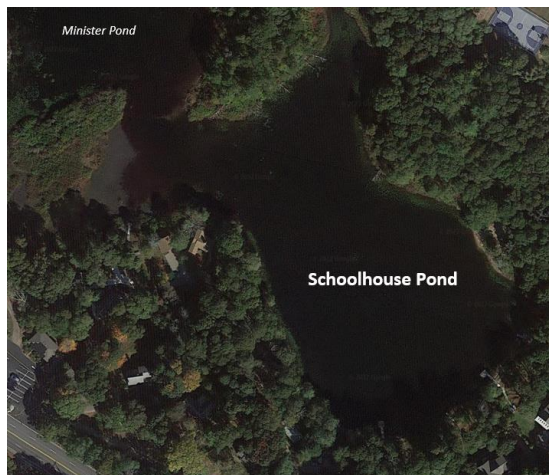
Schoolhouse Pond, Eastham MA

- Contractors to the Town are implementing in-lake remedial measures (aeration, hydroraking) and watershed protection

- Water quality conditions are stable
- Primary phosphorus sources: Birds (26-46%), roads (18-26%), precipitation (14-21%); flow from Minister Pond

- Aeration, hydroraking
- Feasibility analysis of alum treatment

- Septic system maintenance
- Green infrastructure

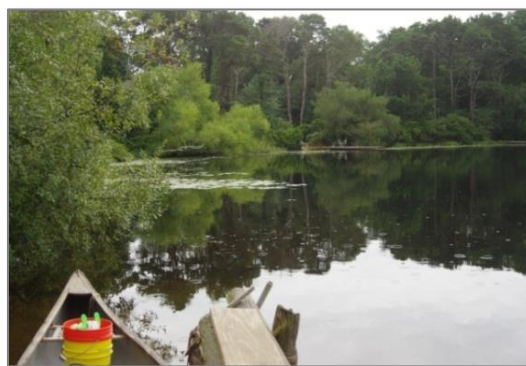
Schoolhouse Pond Water Quality Summary

Water Column	Parameter	Result ¹	"Healthy" Ponds Thresholds ²
Upper Waters	Total Phosphorus	29.7 µg/L	≤10 µg/L
	Chlorophyll-a	18.4 µg/L	≤1.7 µg/L
	Secchi Disk Transparency	1.4 m	Not calculated
Lower Waters	Total Phosphorus	56.8 µg/L	--
	Dissolved Oxygen	2.6 mg/L	--

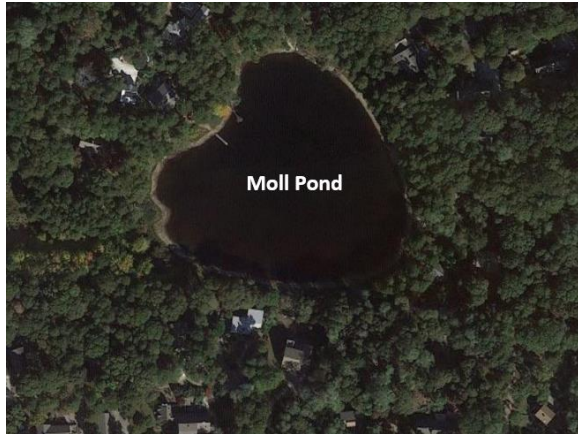
Moll Pond, Eastham MA

- Occasional occurrence of low oxygen conditions in deeper waters
- Possible phosphorus sources: birds, septic, precipitation, road runoff

- The 2018-2020 Priority Waterbodies List cites as impaired by cyanobacteria (HABs)

- Maintain or upgrade septic systems
- Maintain vegetated shoreline
- Discourage large flocks of birds
- Control road runoff

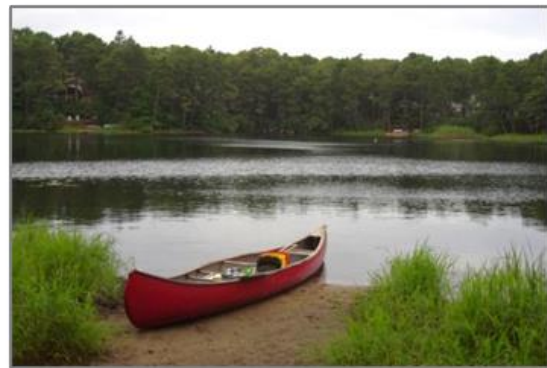
Moll Pond Water Quality Summary

Water Column	Parameter	Result ¹	"Healthy" Ponds Thresholds ²
Upper Waters	Total Phosphorus	30.5 µg/L	≤10 µg/L
	Chlorophyll-a	18.4 µg/L	≤1.7 µg/L
	Secchi Disk Transparency	2.2 m	Not calculated
Lower Waters	Total Phosphorus	41.6 µg/L	--
	Dissolved Oxygen	5.9 mg/L	--

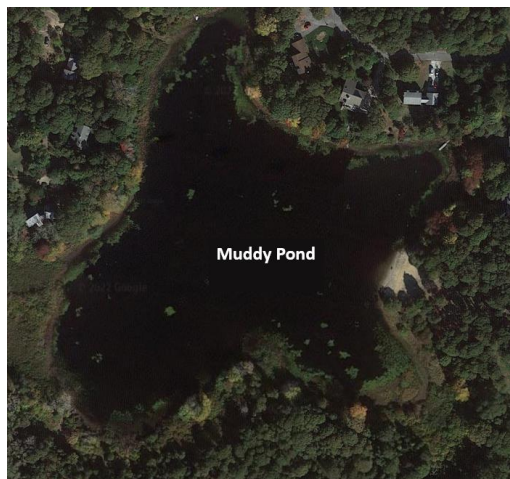
Muddy Pond, Eastham MA

- Impacted by human activities
- Dense aquatic plant growth

- Primary phosphorus sources: Roads (21-45%), septic (0-38%), birds (17-21%), precipitation (10-21%)
- 5 residences within 300 ft. upgradient

- Aquatic plant management
- Resume sampling and monitoring

- Septic system maintenance
- Shoreline protective measures

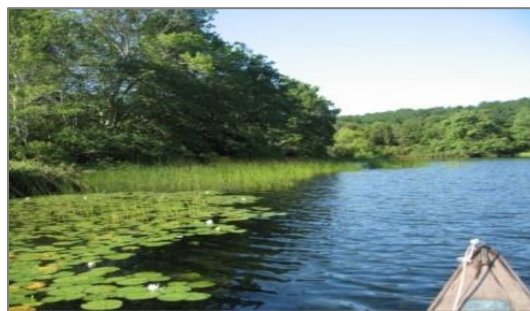
Muddy Pond Water Quality Summary

Water Column	Parameter	Result ¹	"Healthy" Ponds Thresholds ²
Upper Waters	Total Phosphorus	43.9 µg/L	≤10 µg/L
	Chlorophyll-a	24.6 µg/L	≤1.7 µg/L
	Secchi Disk Transparency	1.1 m	Not calculated

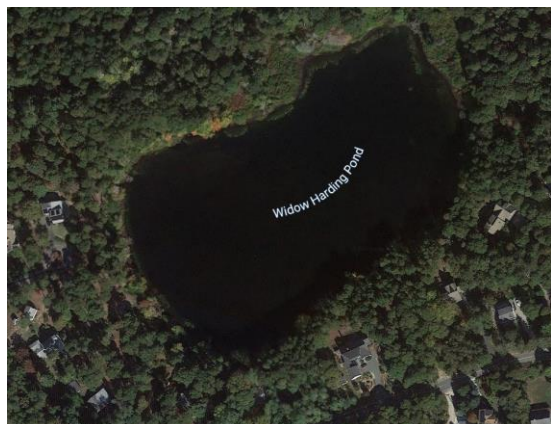
Widow Harding Pond, Eastham MA

- Impacted by human activities
- Transient stratification and low dissolved oxygen

- Possible phosphorus sources: birds, septic, precipitation, and road runoff.

- Resume sampling and monitoring
- Maintain or upgrade septic systems
- Maintain vegetated shoreline, minimize open lawn areas leading to water's edge
- Discourage large flocks of birds
- Control road runoff

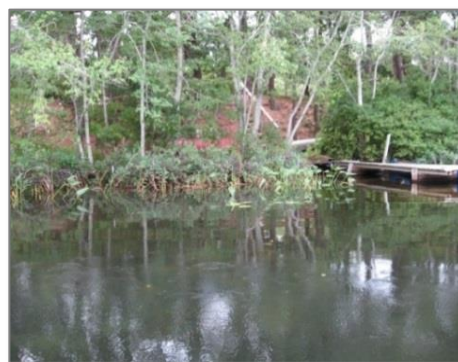
Widow Harding Pond Water Quality Summary

Water Column	Parameter	Result ¹	"Healthy" Ponds Thresholds ²
Upper Waters	Total Phosphorus	32.68 µg/L	≤10 µg/L
	Chlorophyll-a	18.08 µg/L	≤1.7 µg/L
	Secchi Disk Transparency	1.89 m	Not calculated
Lower Waters	Total Phosphorus	28.69 µg/L	--
	Dissolved Oxygen	5.08 mg/L	--
