Eastham Freshwater Ponds: Water Quality Status and Recommendations for Future Activities

FINAL REPORT

April 2009

Town of Eastham
and
Barnstable County

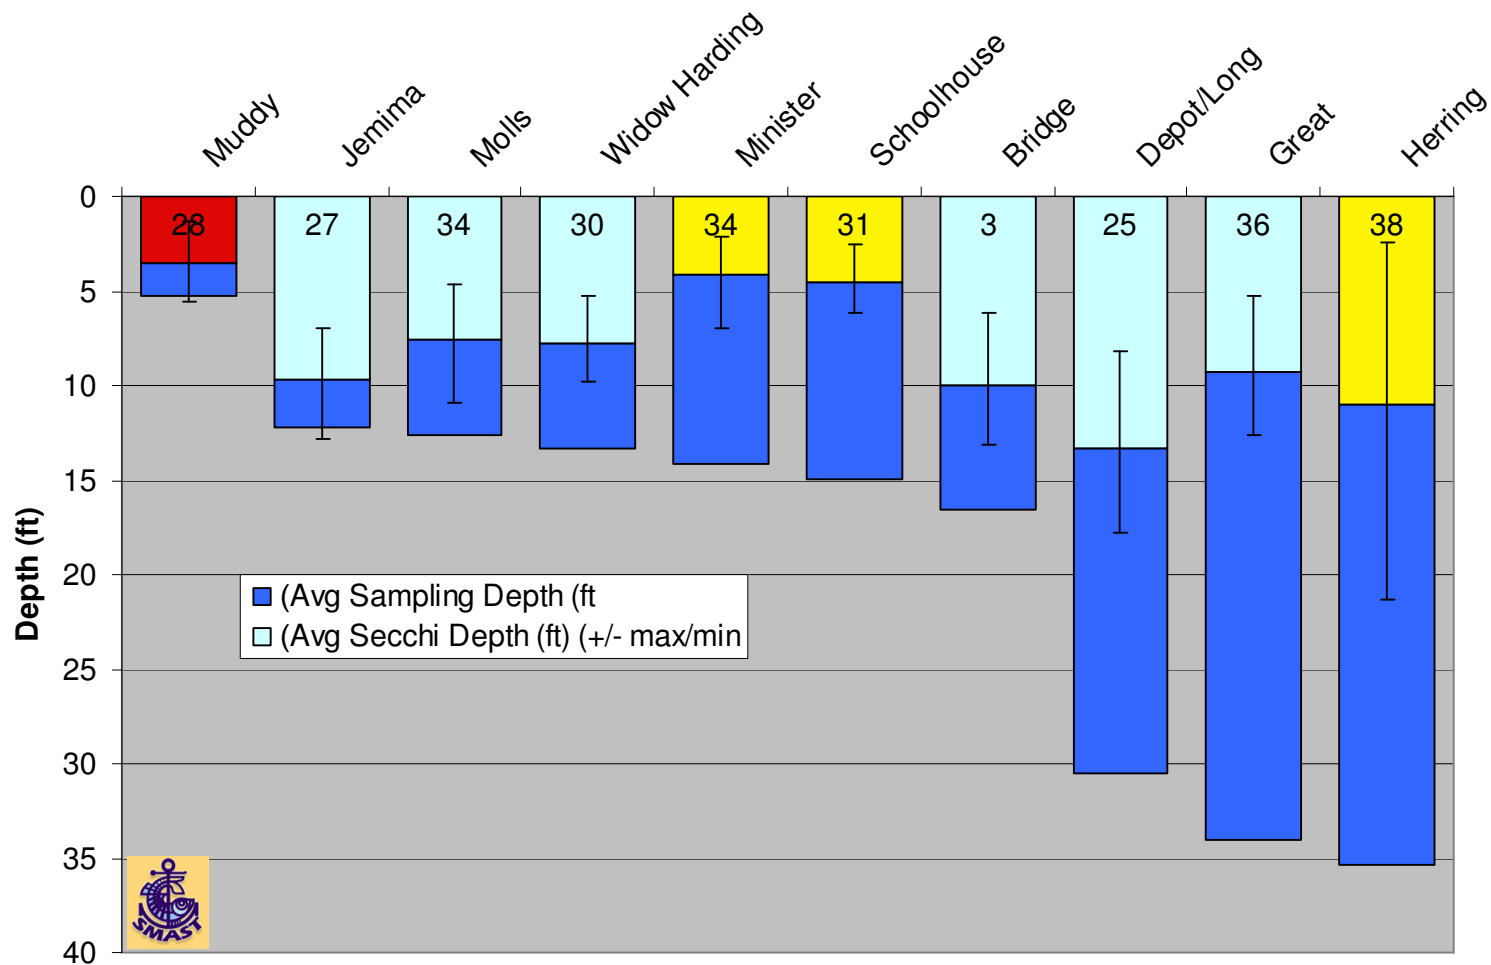
Figure III-2. Average Secchi Transparency Readings in Eastham Ponds 2011-2016

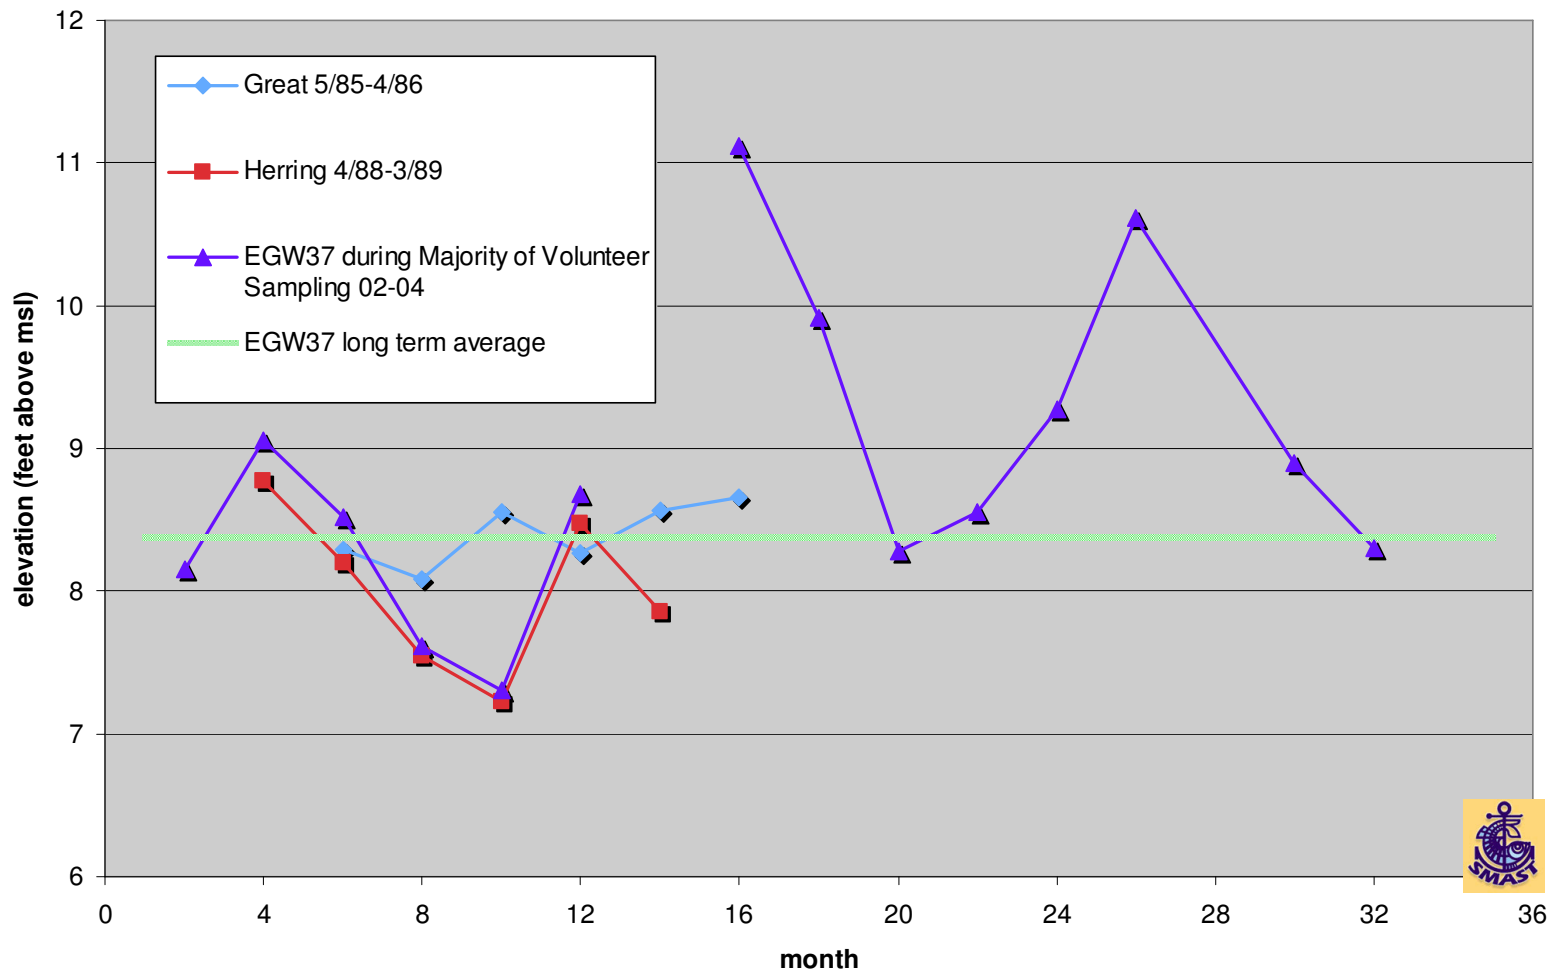
Figure V-2. Groundwater Elevations at EGW37 during pond sampling periods

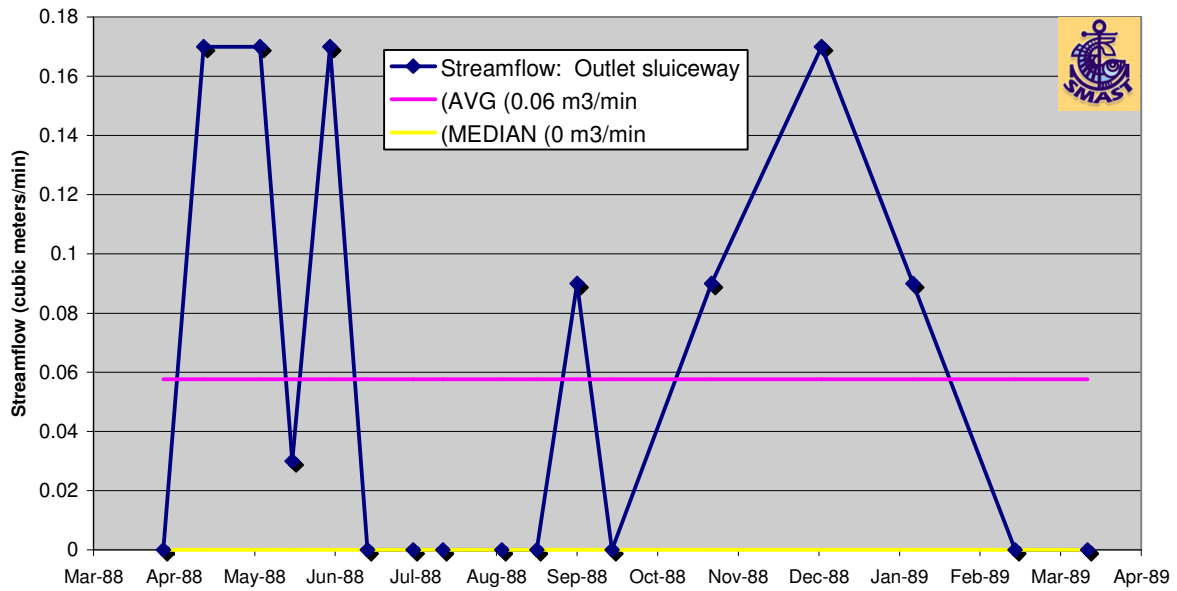
a. Great Pond: Outlet to Bridge Pd

b. Herring Pond: Outlet sluiceway at Town Landing

Figure V-3. Historic Outlet Streamflow from Great Pond and Herring Pond
 a. Great Pond outflow streamflow data from BEC (1987). b. Herring Pond outflow streamflow data from BEC (1991).

In contrast to Great Pond outflow, Herring Pond outflow stream data from April 5, 1988 to March 15, 1989 shows very little water leaving the pond through the stream. Average, median, maximum, and minimum outflow readings from Herring are 0.06, 0, 0.17, and 0 m³/min (see Figure V-3). Because streamflow is relatively small, groundwater is the predominant source of inflow and outflow in Herring. Local observers have noted occasional salt water flow into Herring Pond; this was not noted in BEC (1991), but should be noted in subsequent measurements.

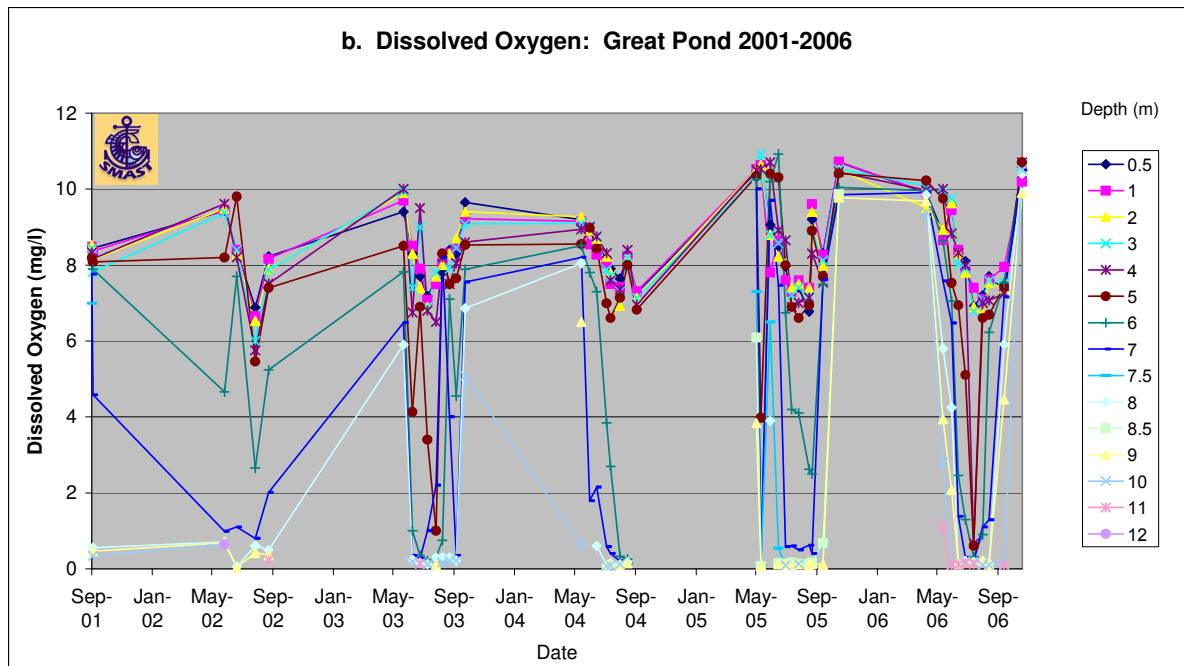
Figure VI-1. Great Pond Temperature and DO Readings 2001-2006

Temperature data shows that the upper water column is well mixed with temperatures increasing during summers, while the deeper waters get colder with increasing depth. During early spring and late fall, water temperatures are relatively constant throughout the water column. Dissolved oxygen concentrations show lower concentrations with increasing depth and regular anoxic (<1 ppm) concentrations during the summer. All data collected by Eastham volunteers using DO/Temp meters. These graphs include data documented in Eichner and others (2001) and PALS Snapshots from 2001 to 2006.

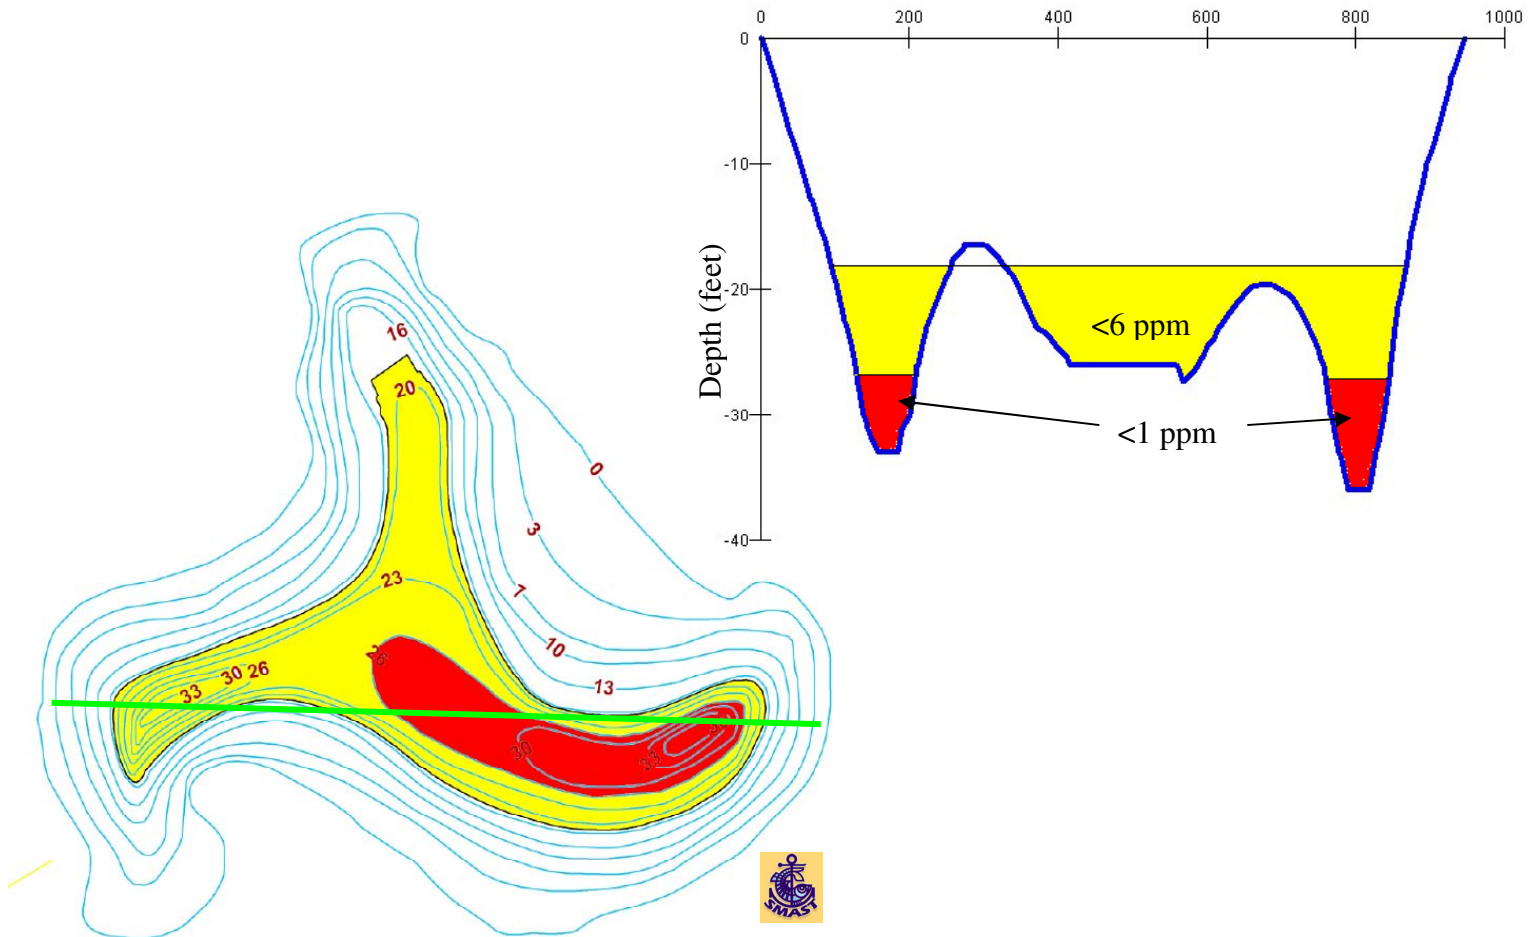
Figure VI-3. Great Pond: Average dissolved oxygen (June through September) and state surface water standards Depth profile and bathymetric map showing volume and area of Great Pond that has average dissolved oxygen concentration between June and September that is less than state regulatory limit of 6-ppm DO standard for cold water fisheries (shaded yellow) and areas that are anoxic (<1 ppm) (shaded red). Green line on map shows depth profile track through the pond that corresponds to cross-section. Bathymetry is from BEC (1987).

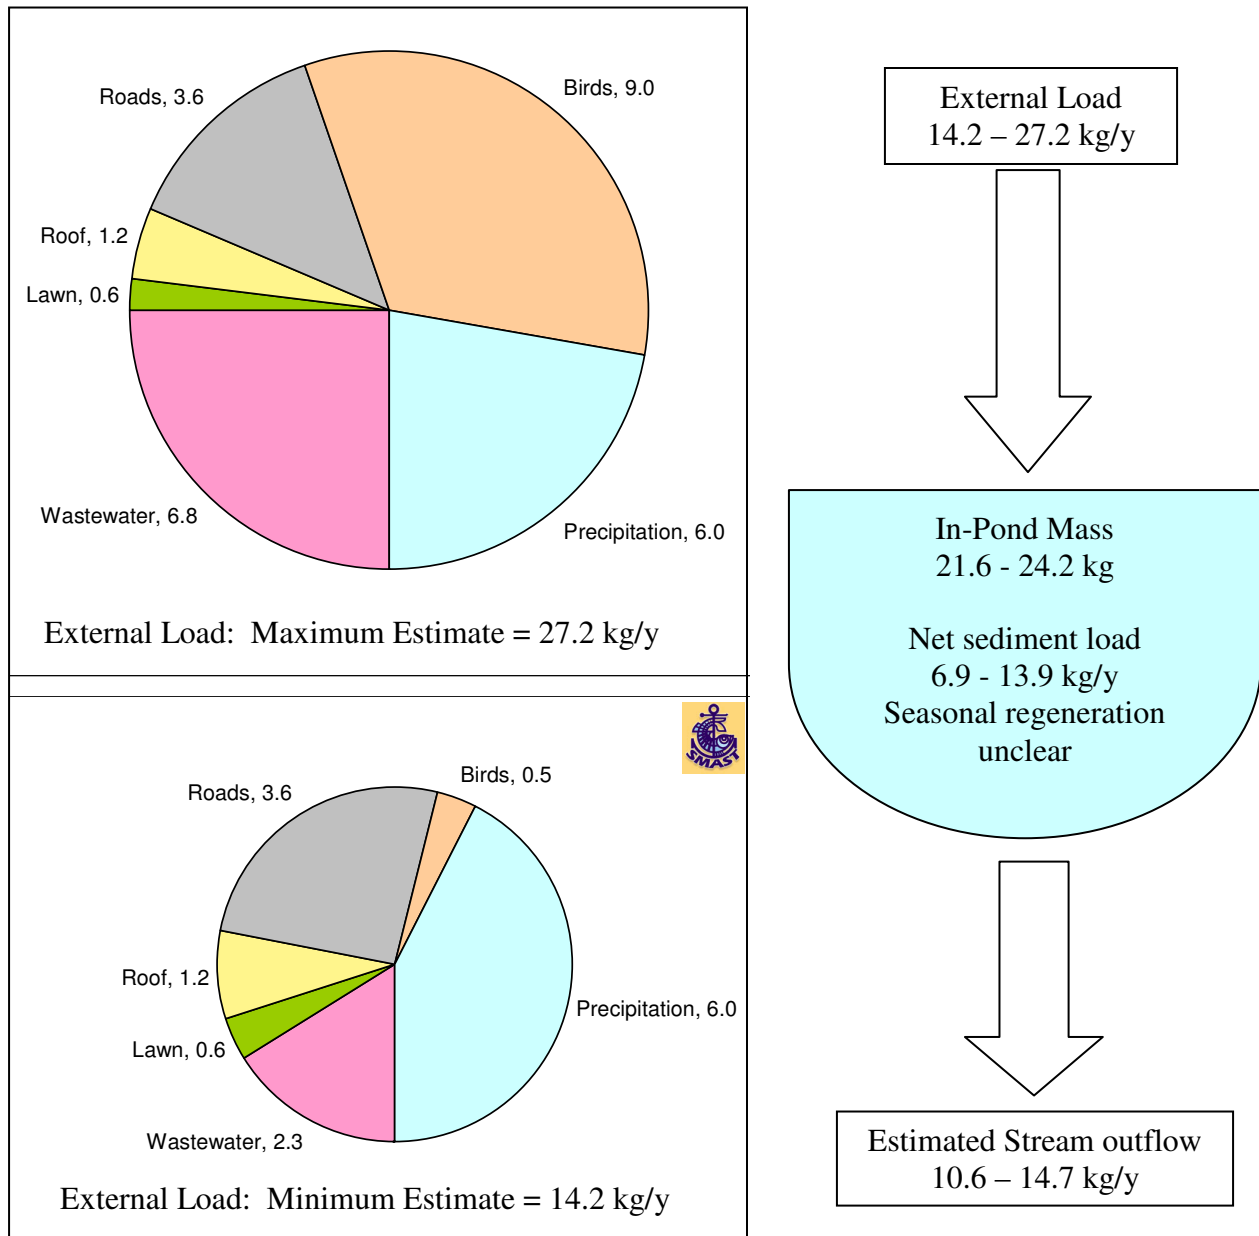
Figure VI-5. Estimated phosphorus budget for Great Pond

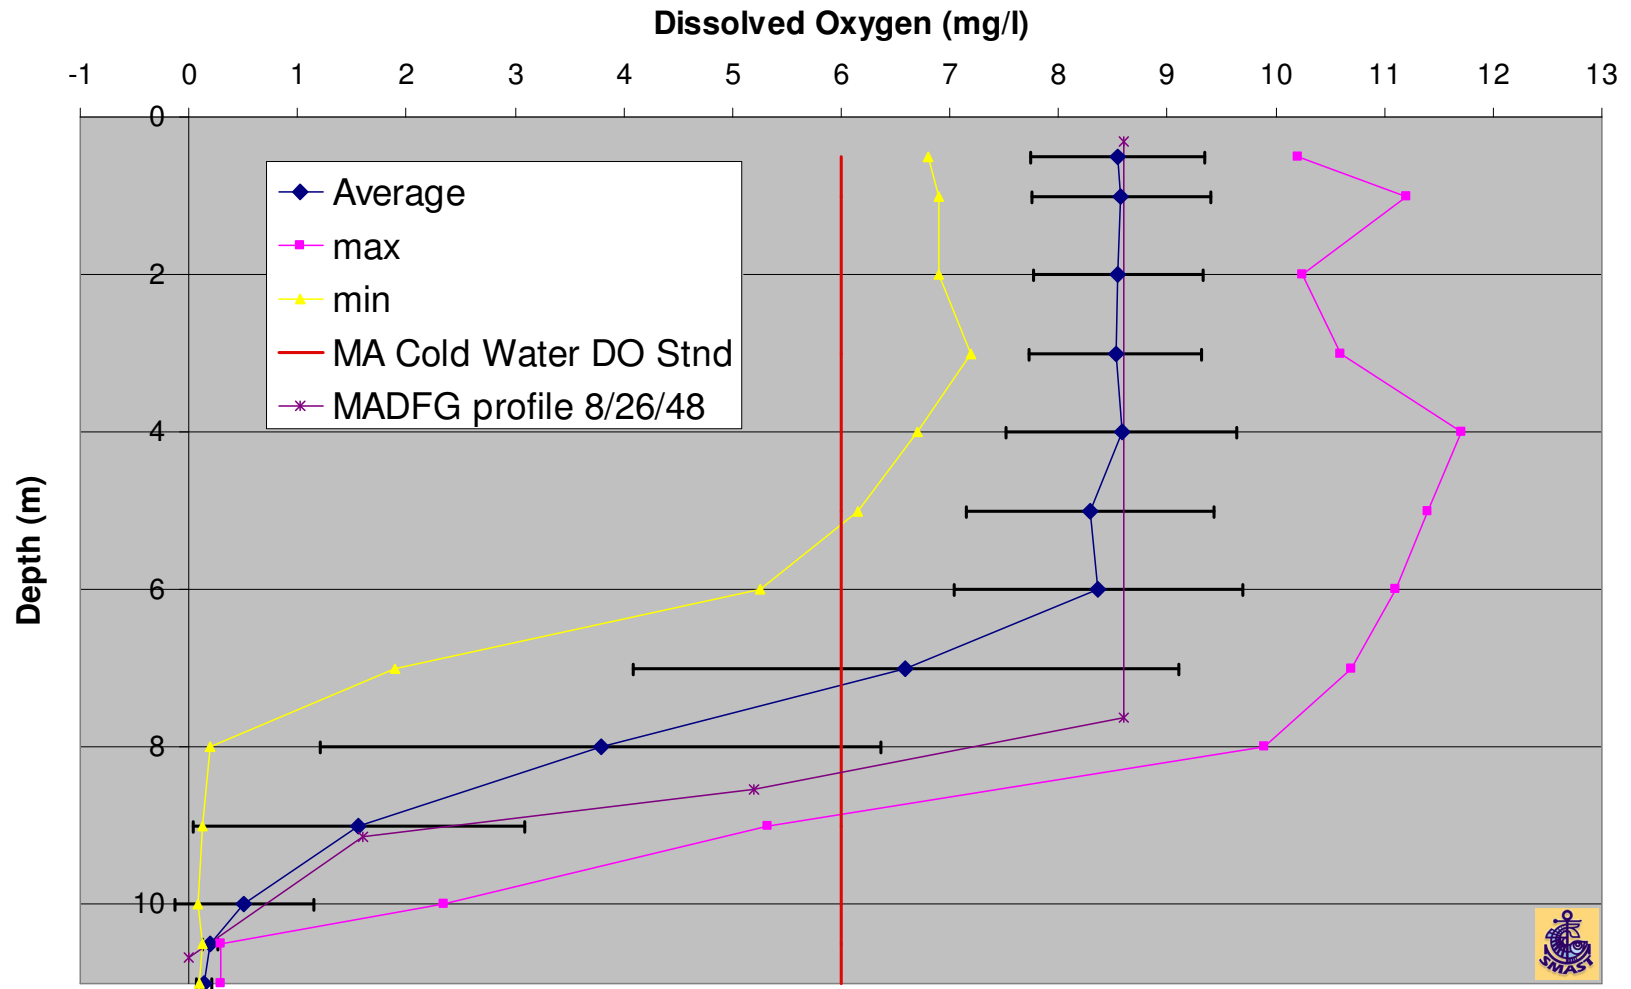
Figure VI-7. Average dissolved oxygen concentrations in Herring Pond (June through September, 2001-2006) Graph shows average DO profile based on data collected by town volunteers between 2001 and 2006 with error bars (± 1 standard deviation) plus maximum and minimum readings for each depth. Also shown is August 26, 1948 profile (MADFG, 1948) and the state surface water 6-ppm DO standard for cold water fisheries (310 CMR 4). Average concentrations at most depths are based on 35 readings collected between 2001 and 2006.

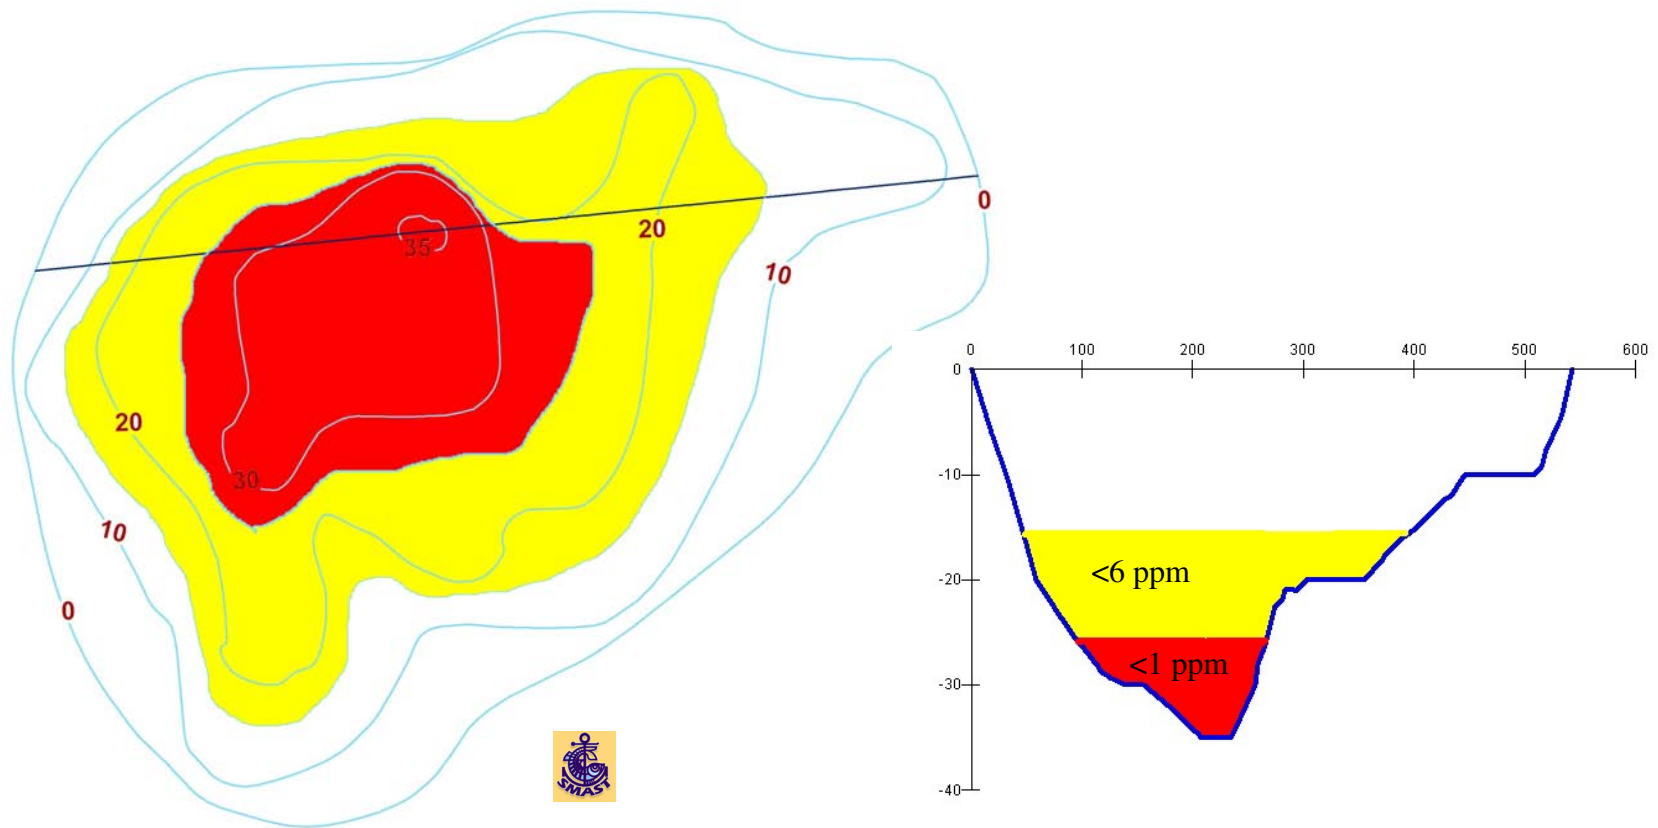
Figure VI-8. Herring Pond: Comparison of average dissolved oxygen (June through September) and state surface water standards

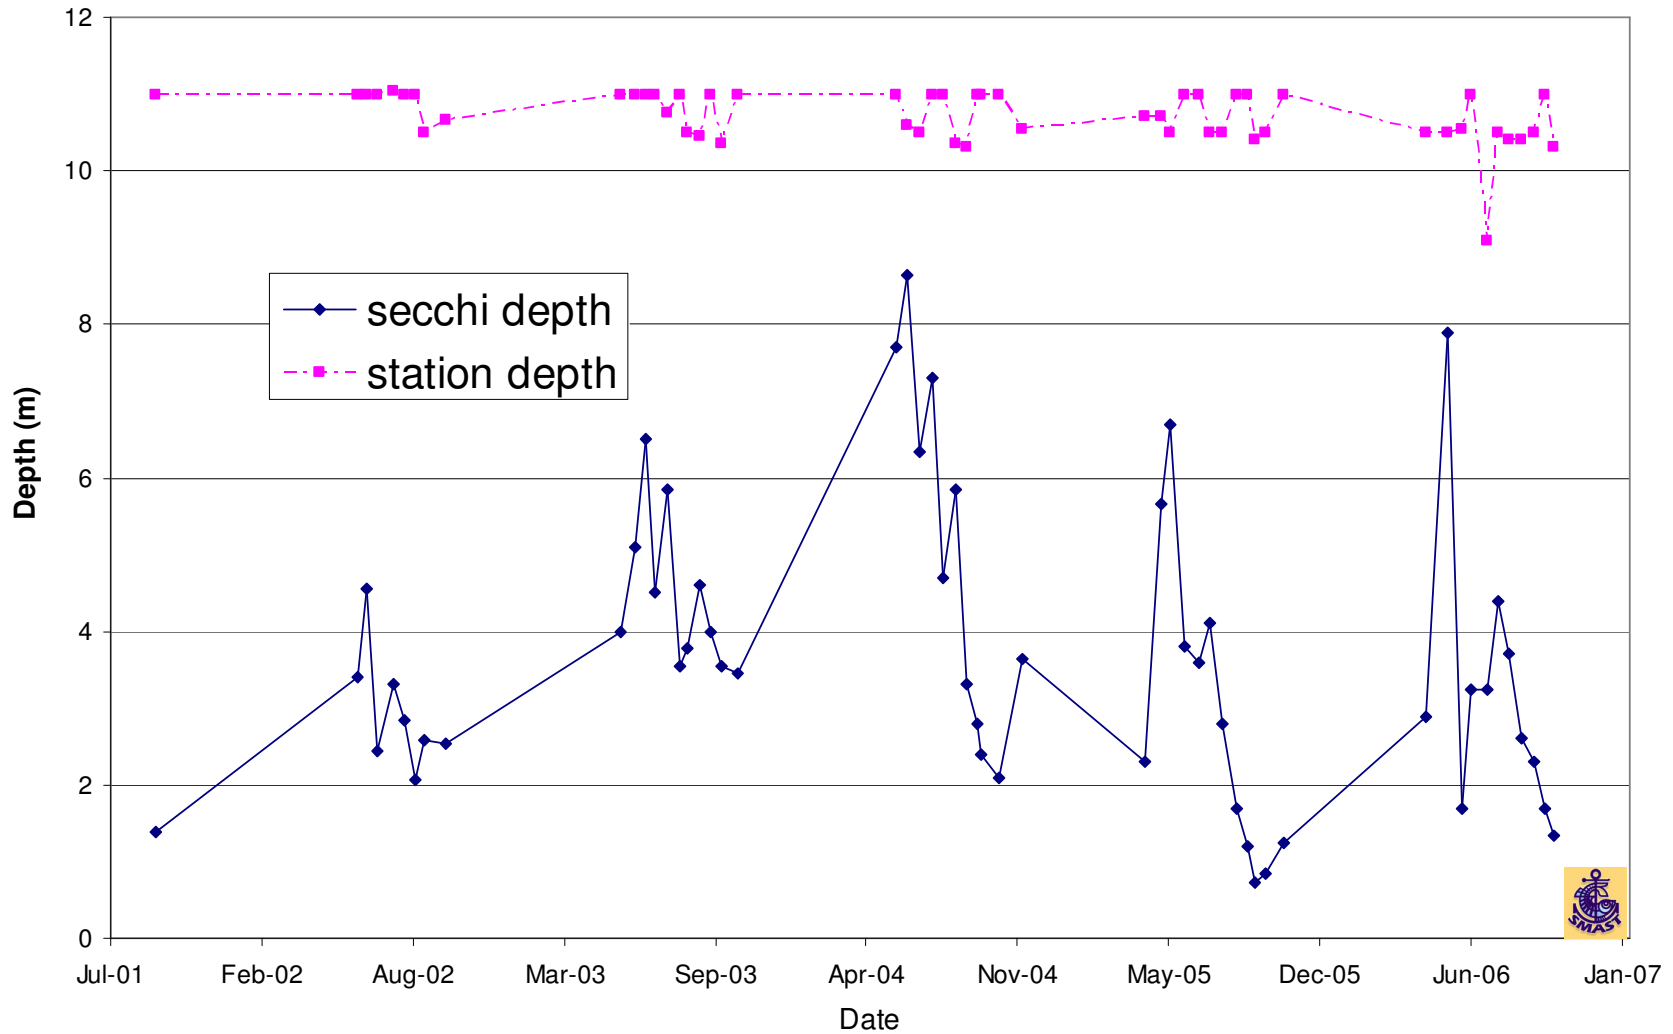
Figure VI-9. Secchi transparency readings in Herring Pond 2001-2006

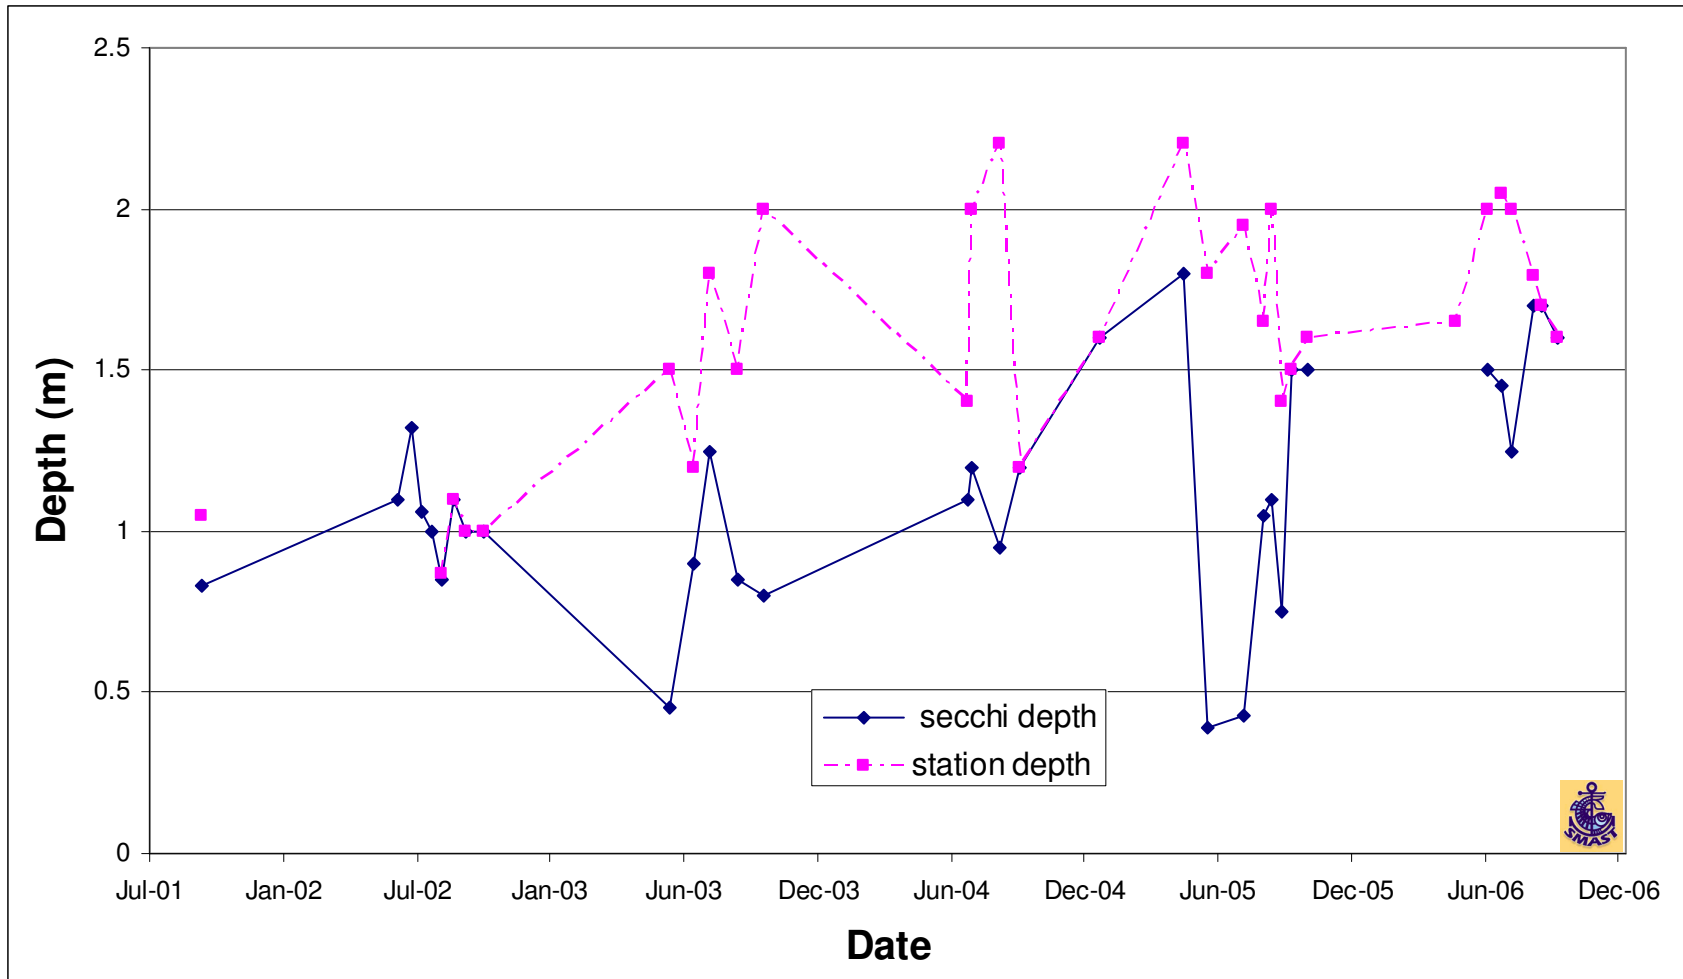
Figure VI-14. Secchi transparency readings in Muddy Pond 2001-2006

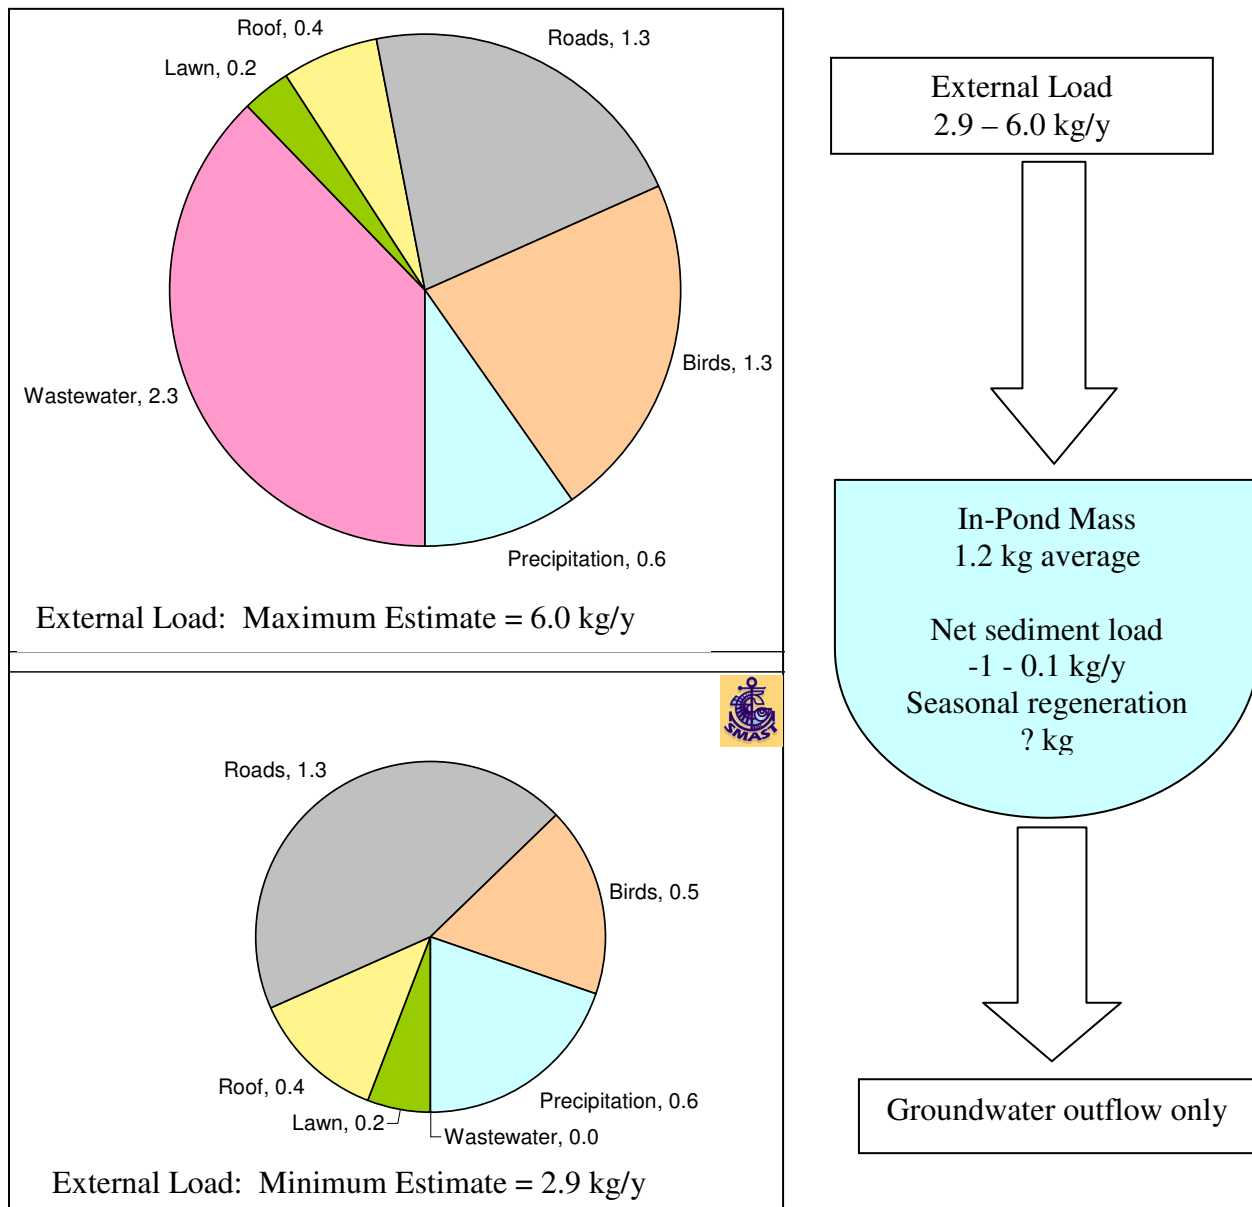
Figure VI-15. Estimated phosphorus budget for Muddy Pond

In-lake mass is based on collected 2001-2006 water quality data. Wastewater load from upgradient properties within the 300 ft buffer based on septic load travel time of 35 to 81 years. Road loads include all areas within 300 ft buffer. Wastewater has the largest range, but bird loading is the most uncertain. Bird loading depends on an areal or per pond estimate and it is recommended that a bird survey be conducted to provide a Muddy Pond-specific estimate. Wastewater loading factors are reasonably well understood, so time of travel is likely the key variable in the estimate of wastewater load; steady-state wastewater load is projected to be the same as the upper end of the current projected range (6.0 kg/y). Other loads based on factors from Table V-3. Groundwater outflow is the only potential discharge of phosphorus from the pond. Net sediment load is based on comparison of external load and in-lake mass. Determination of sediment regeneration would require direct measurement through collection and testing of sediment cores.

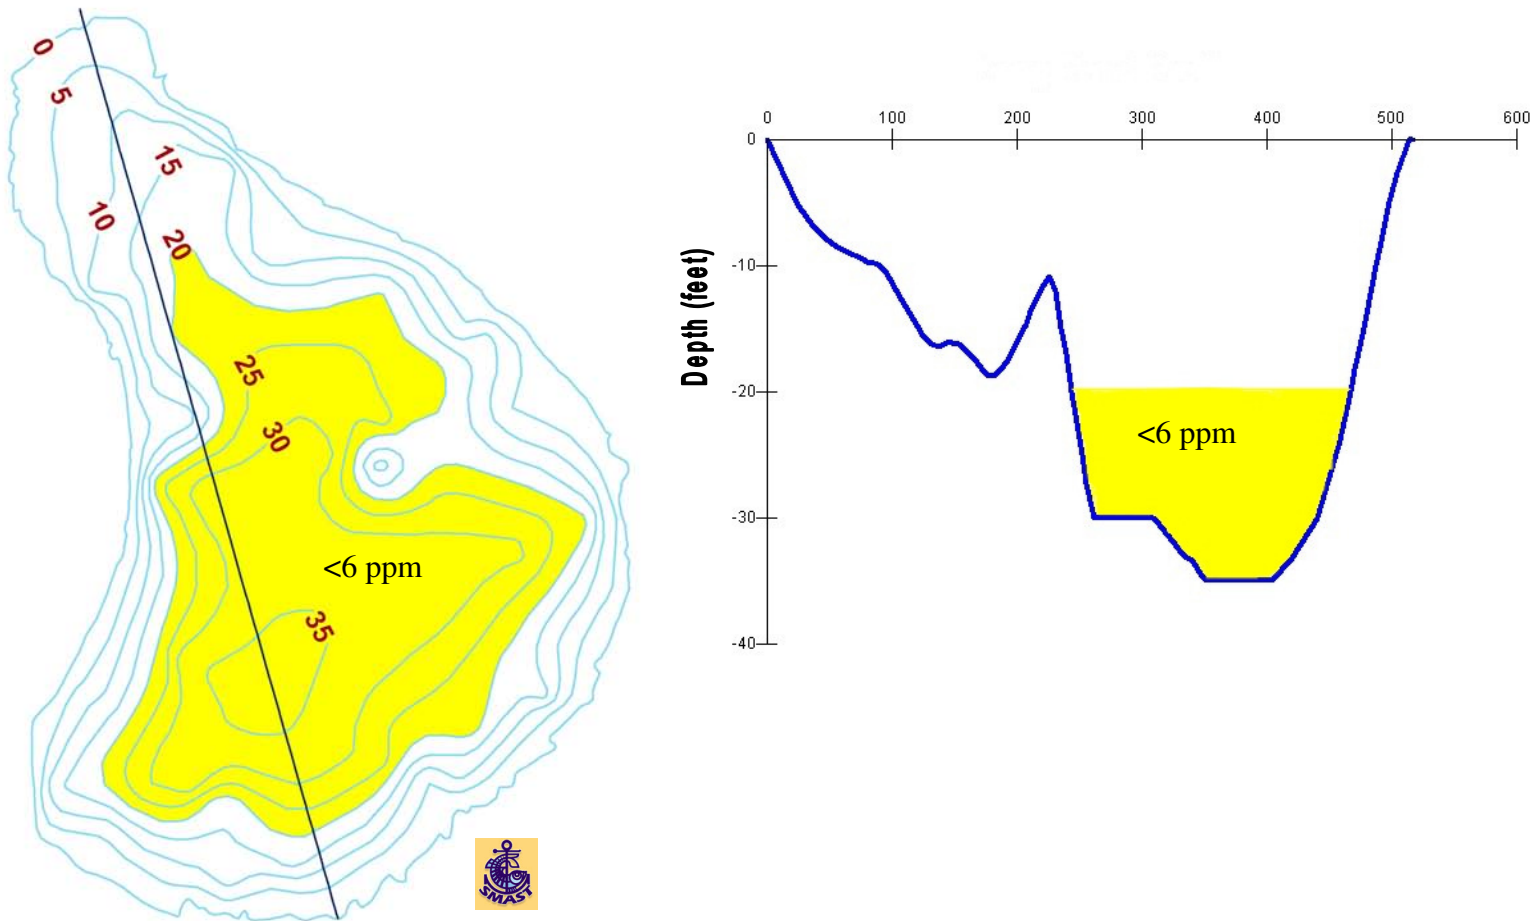
Figure VI-20. Depot Pond: Comparison of average dissolved oxygen (June through September) and state surface water standards

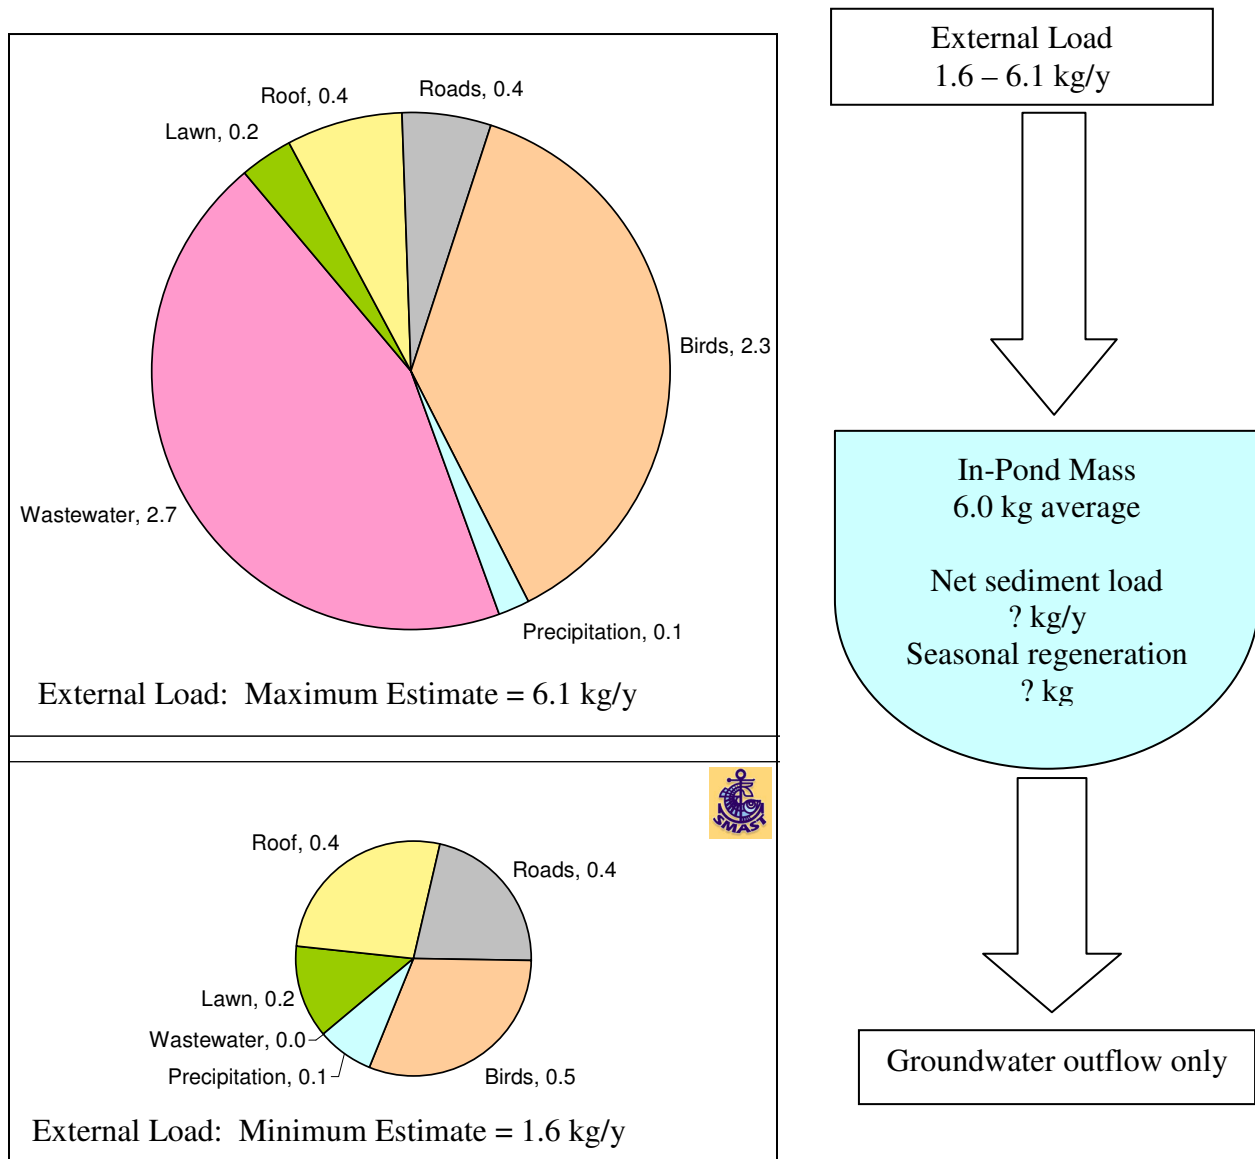
Figure VI-22. Estimated phosphorus budget for Depot Pond

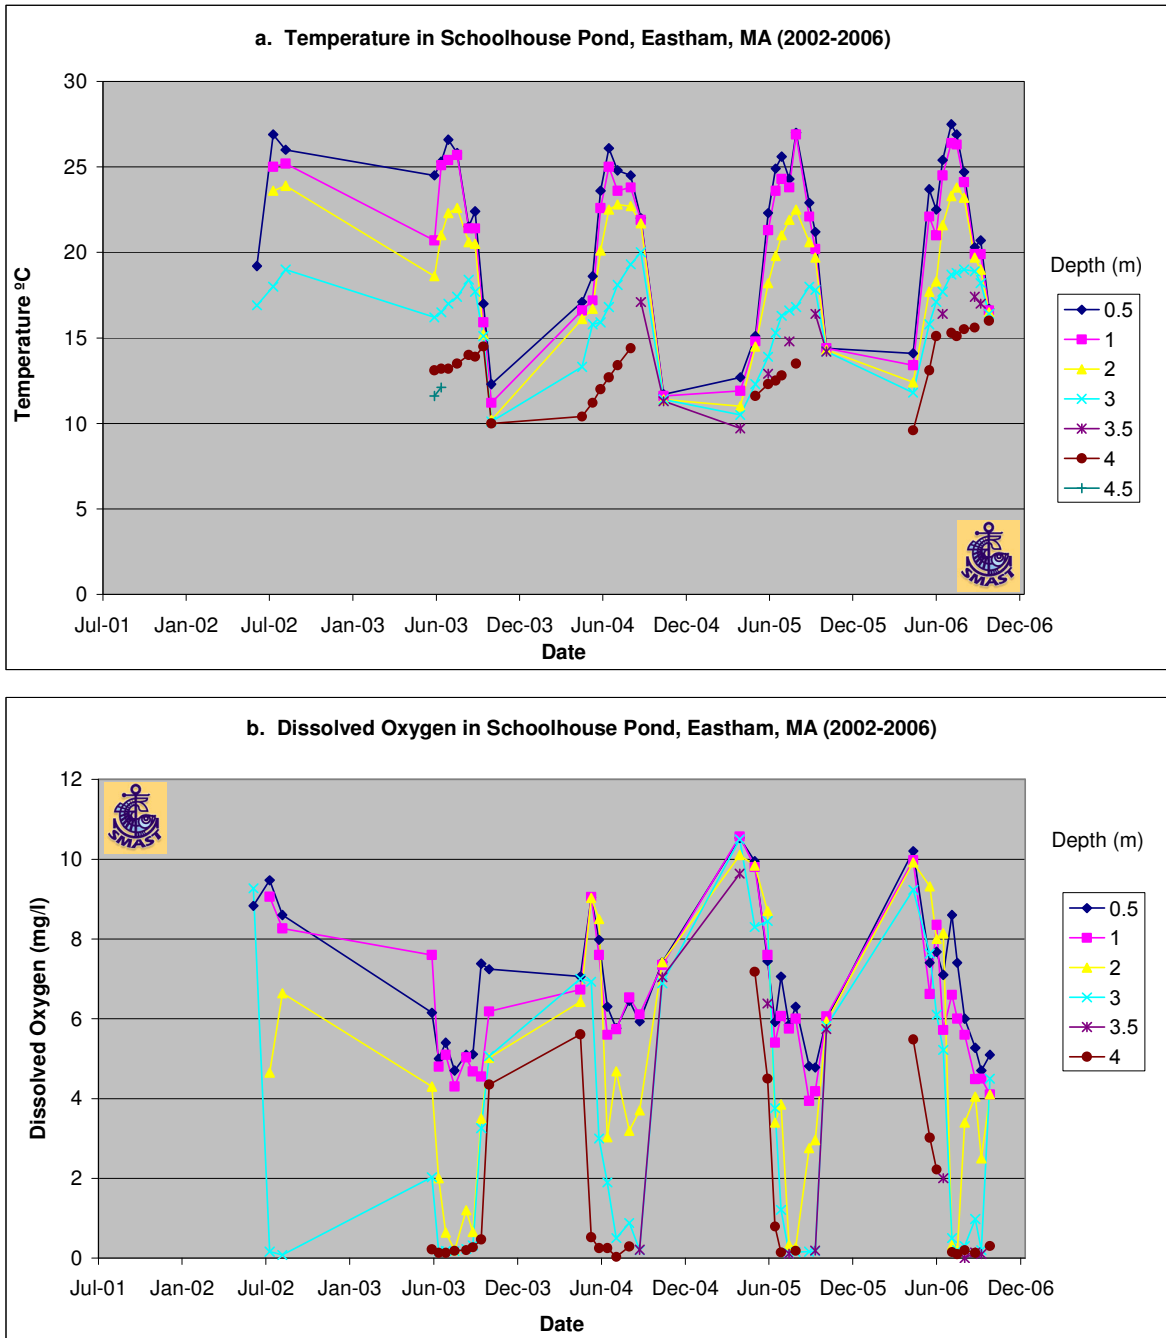
Figure VI-24. Schoolhouse Pond Temperature and DO Readings 2002-2006
 Temperature data shows that the upper 1 m of the water column is well mixed with temperatures getting colder with increasing depth. Waters below 3 m consistently meet the 20°C regulatory threshold listed by the state for cold water fisheries (314 CMR 4). During early spring and late fall, water temperatures are relatively constant throughout the water column. Dissolved oxygen concentrations show lower concentrations with increasing depth and regular anoxic (<1 ppm) concentrations during the summer, which reach as high as 2 m below the surface. All data collected by Eastham volunteers using DO/Temperature meters between 2001 and 2006 and includes data from Cape Cod PALS Snapshots.

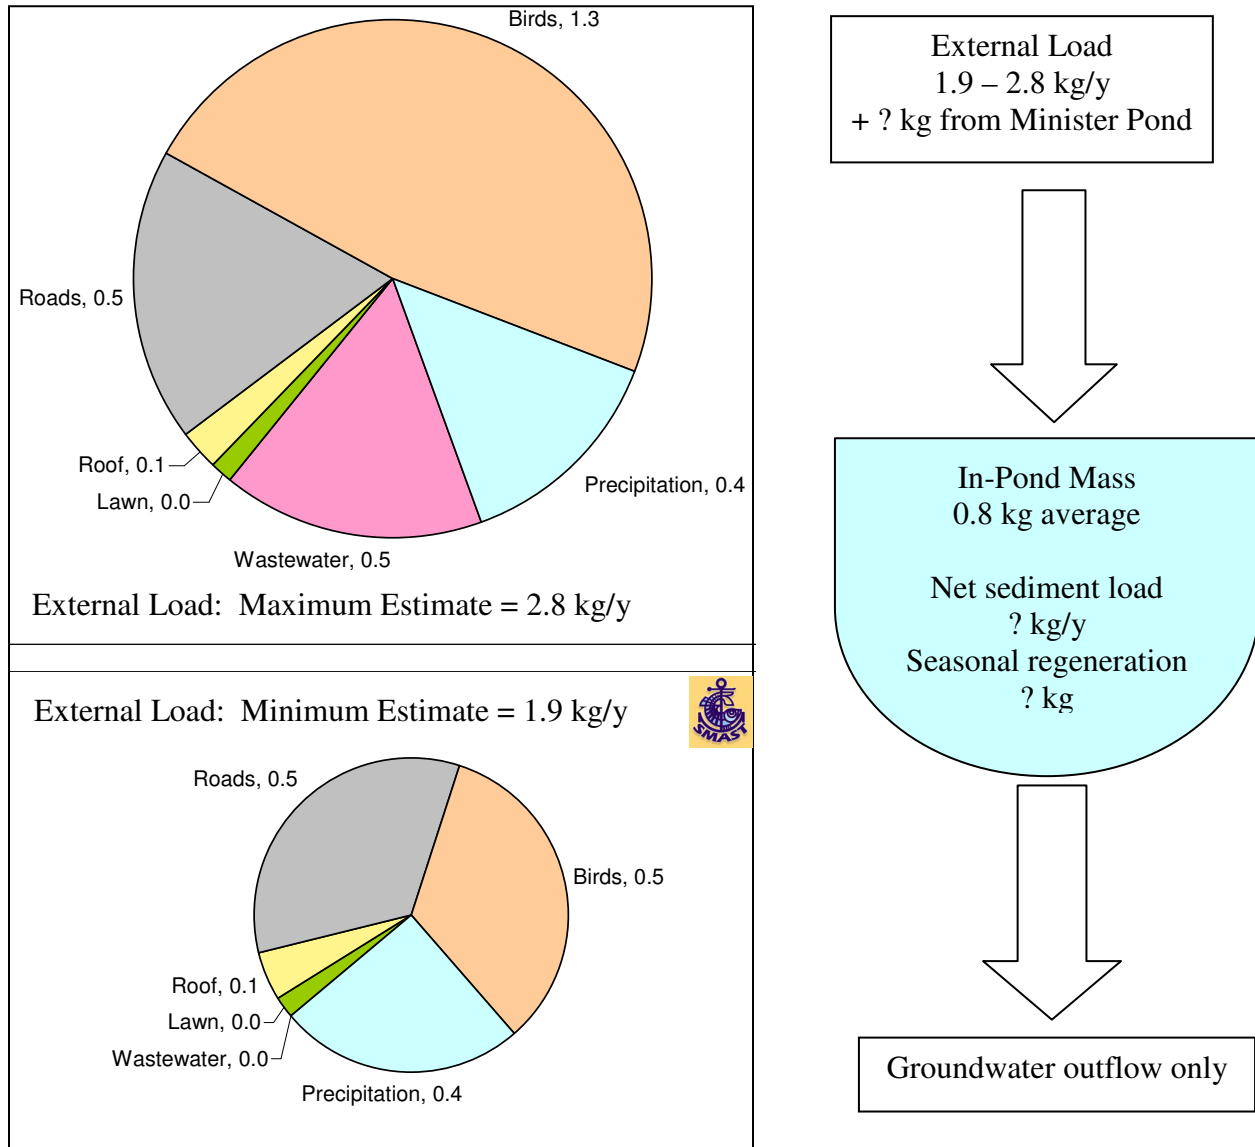
Figure VI-30. Estimated phosphorus budget for Schoolhouse Pond
